Railroad Investigation Report: RIR-24-08

CSX Transportation Employee Fatality

Cumberland, Maryland

August 6, 2023

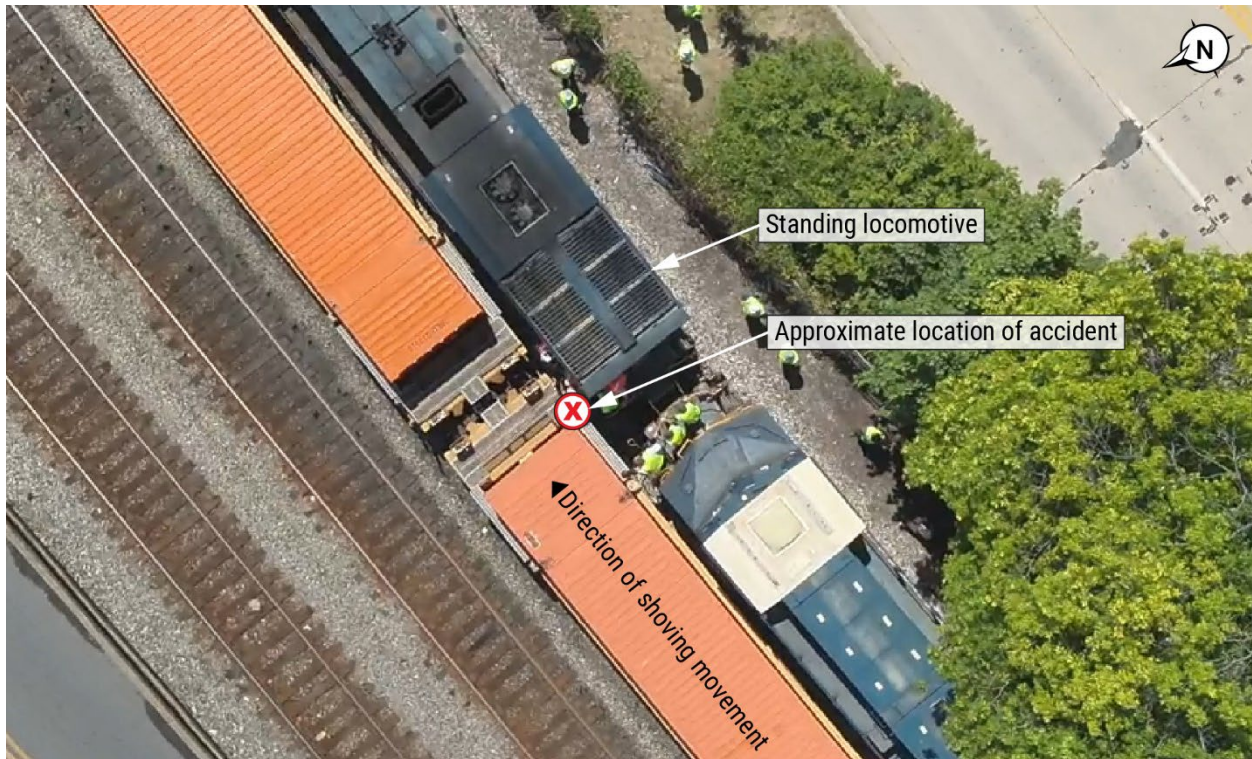
Figure 1. Aerial view of the accident scene. (Source: CSX.)

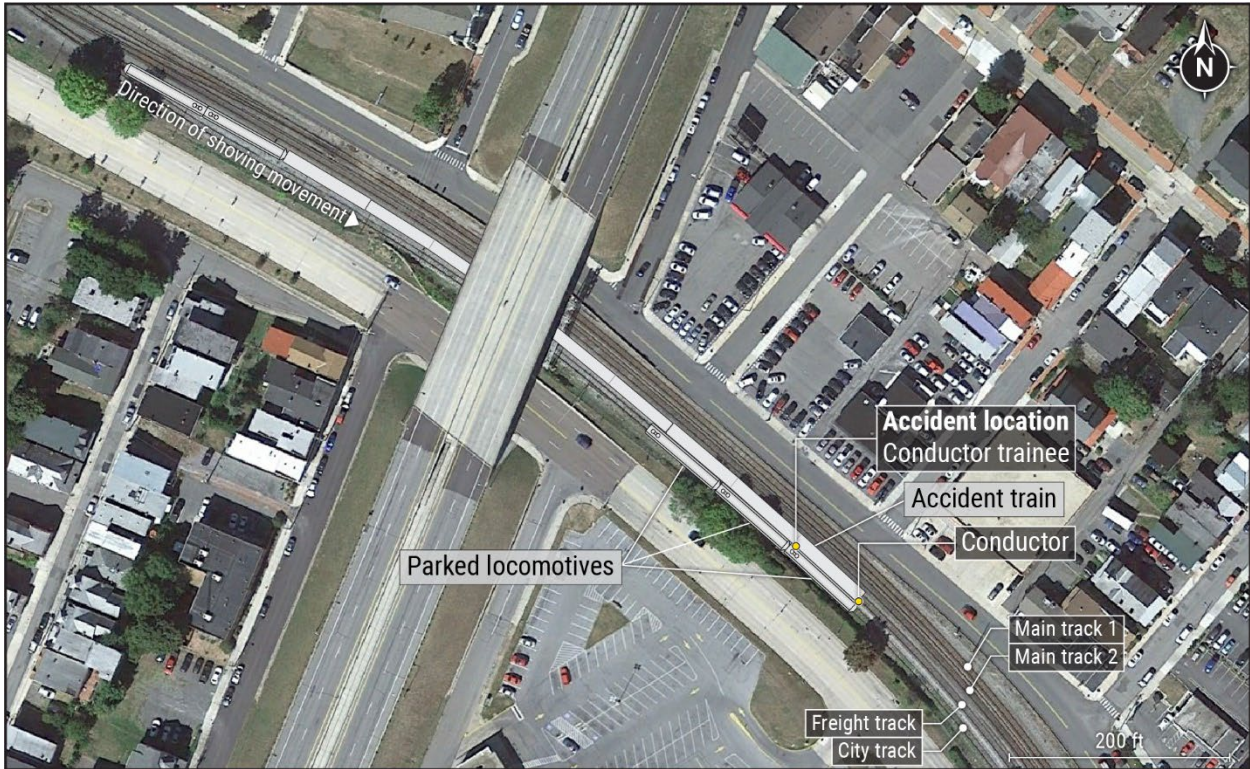
In Cumberland Yard, the crew received instructions to pick up railcars from a yard track, an operation that would involve a shoving movement on the freight track. (See figure 2.) The parked locomotive involved in the accident was one of three positioned on the city track, which was roughly parallel to the main tracks and separated from them by the freight track. None of these locomotives were relevant to the crew's assignment.

Figure 2. Expanded overhead view of the accident scene. (Source: Google Earth.)

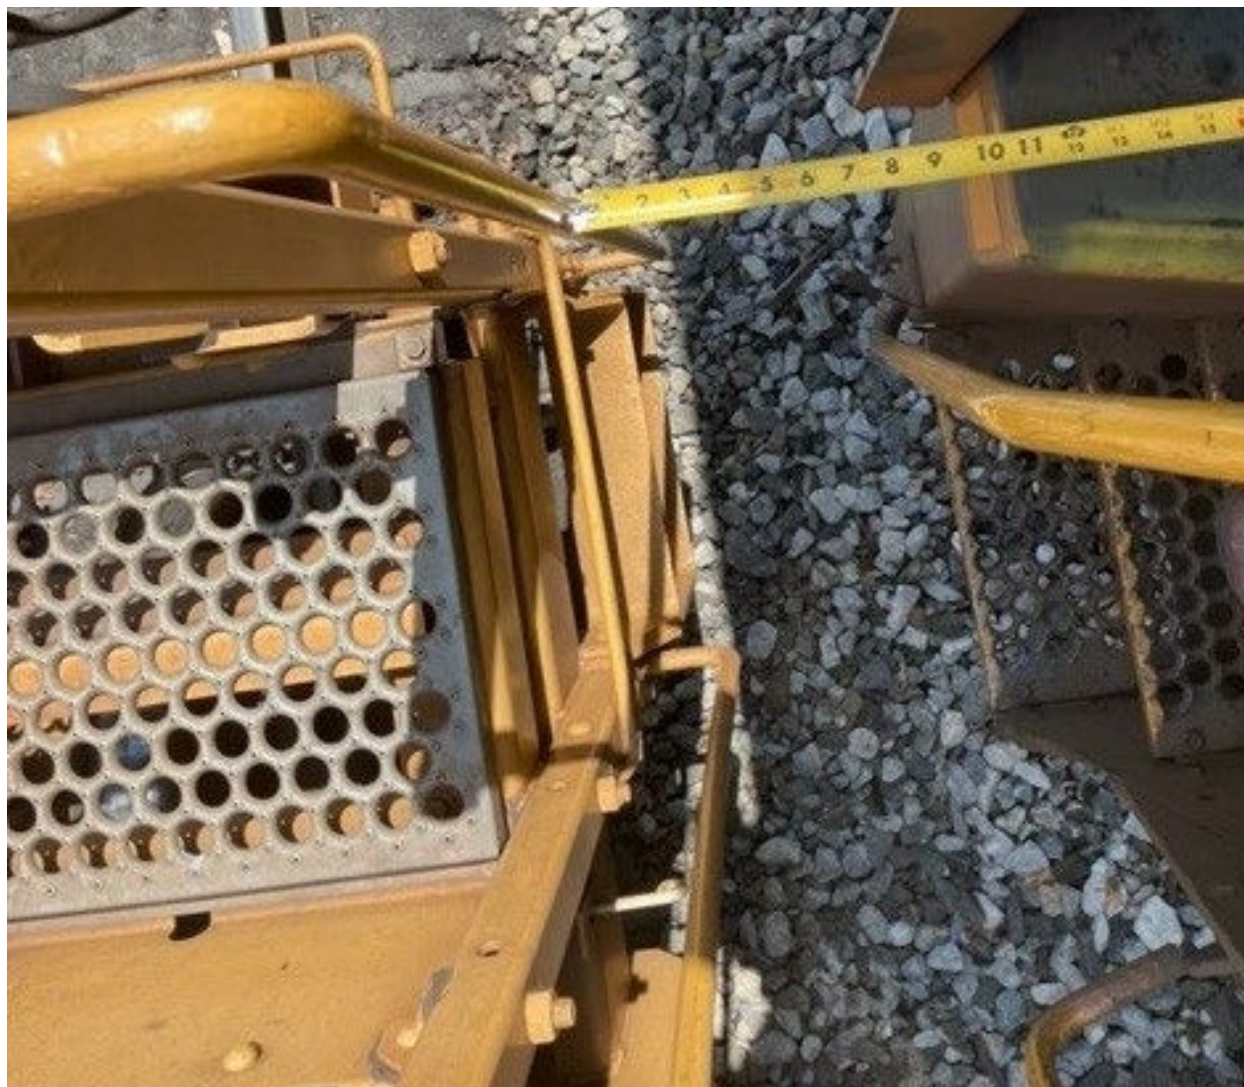
During postaccident examinations, the NTSB measured 7 inches of clearance between the ladder the conductor trainee was riding and the closest point on the eastern locomotive parked on the city track. (See figure 3.) The location was not included in CSX's list of close clearances or marked with signage.

Figure 3. Clearance between railcar (left) and parked locomotive (right).

The parked locomotives created a close clearance location because the city track where they were positioned was unusually close to the freight track being used by the accident train. The distance between the track centerlines was slightly more than 11 feet—or 3 feet less than both the current AREMA standard and the CSX standard for new or reconstructed track. Based on NTSB measurements on the scene, an additional 3 feet of clearance would have prevented the accident.

- Removed the city track from service immediately after the accident; as of this report, it remains out of service and is scheduled for removal.
- Issued safety alert with a safety briefing on temporary close clearances on August 10, 2023.
- Revised rules for field training such that when an employee with less than 1 year of service is assigned a trainee, a supervisor must be contacted prior to performing any work.
- Used geographic information system data to identify track centerlines 12 feet 6 inches apart or closer, flagged these tracks, and put in the existing close clearance index.¹¹
