Railroad Investigation Report: RIR-24-09

# Norfolk Southern Railway Train Derailment

Anniston, Alabama

March 9, 2023

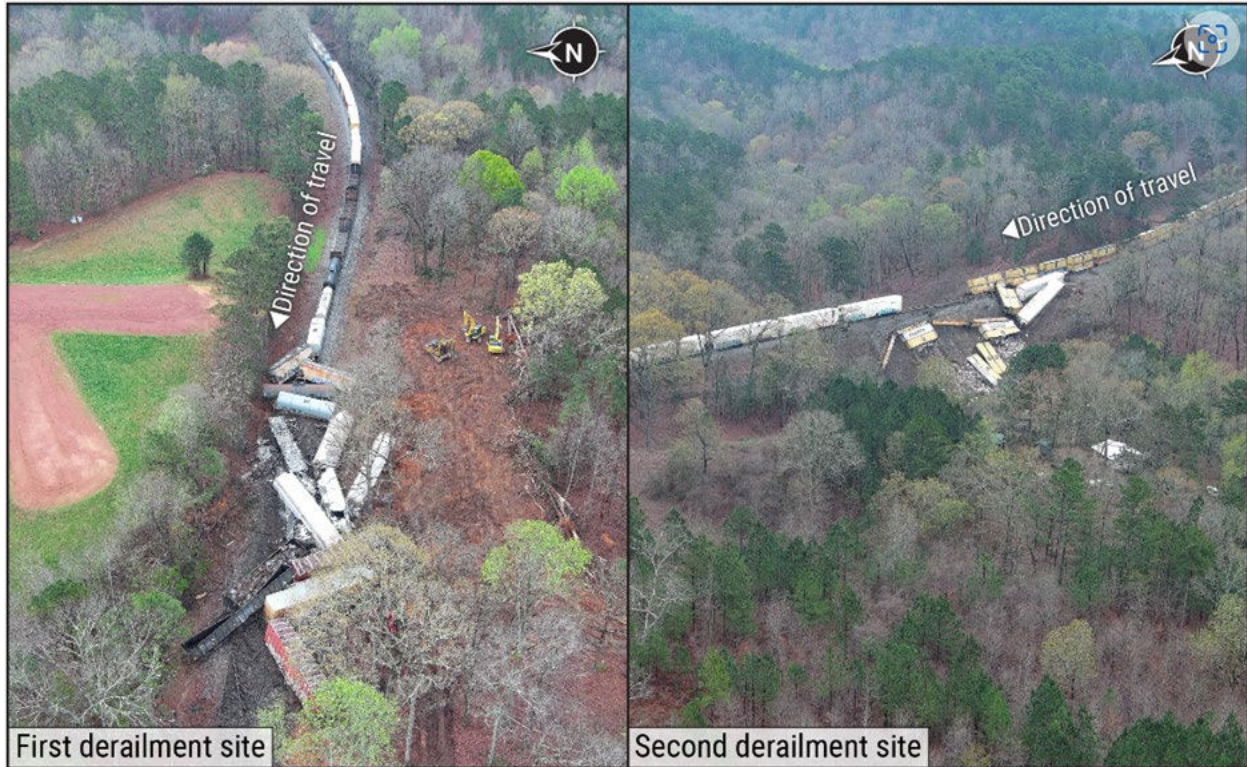
On March 9, 2023, about 6:19 a.m. local time, westbound Norfolk Southern Railway (NS) freight train 245A109 derailed 2 locomotives and 37 railcars on the Alabama East End District of its Gulf Division near Anniston, Alabama.<sup>1</sup> The derailment involved two sections of the train, resulting in two derailment sites. The first derailment site was located at the front of the train and where 2 locomotives and 29 railcars derailed. At the second site, located near the rear of the train, eight railcars derailed. Three of the cars that derailed were tank cars carrying hazardous materials. These tank cars remained intact and did not release hazardous materials. There were no reported fatalities or injuries. NS estimated damages to equipment, track, and signal infrastructure to be about \$2.9 million. At the time of the accident, visibility conditions were clear with early morning daylight; the weather was 57°F with no precipitation. Figure 1 shows the accident scenes.

**Figure 1.** Aerial view of the first derailment site (left) and the second derailment site (right). (Courtesy of NS.)

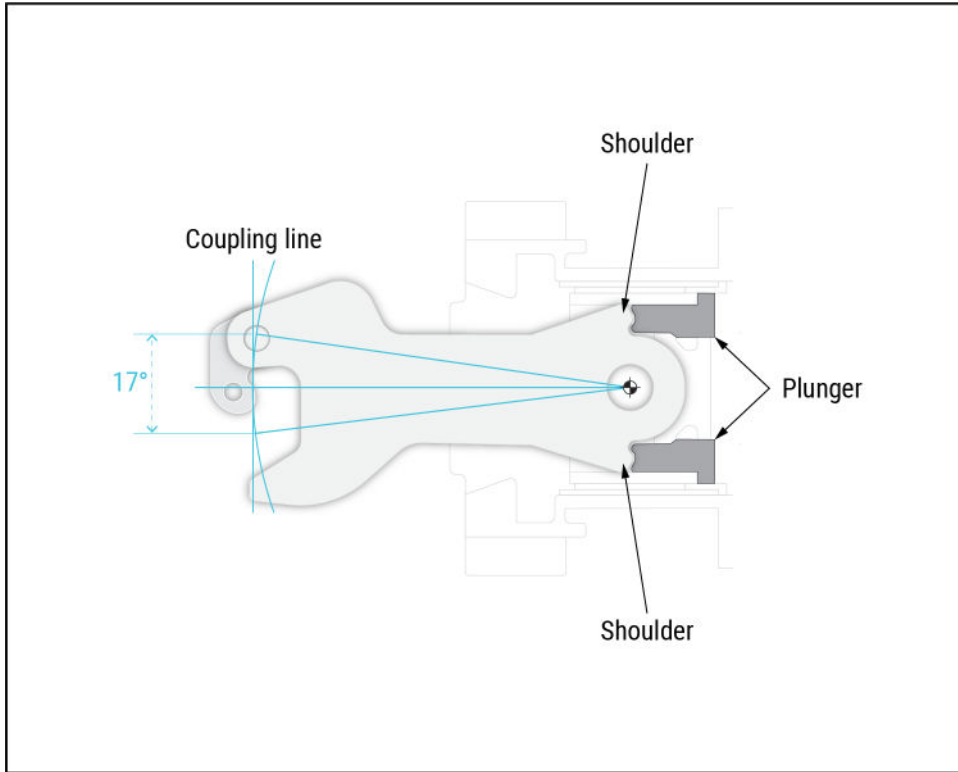
forces activate the draft gear and the plungers provide a centering torque to the coupler, limiting drawbar angles and centering the coupler in the coupler pocket. (See figure 2.)<sup>6</sup>

**Figure 2.** Alignment control coupler with plungers.

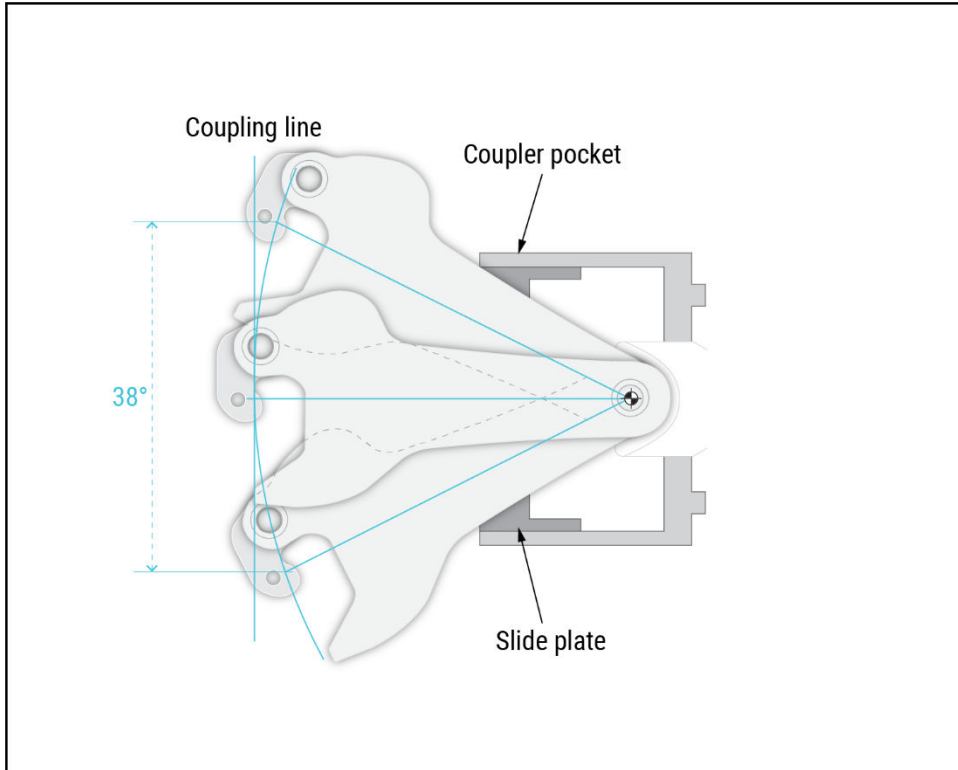
Locomotives used extensively to switch railcars, like the RMEX 08 and RMEX 06, may be equipped with nonalignment control couplers. (See figure 3.) These couplers lack the shoulders and are not equipped with the draft gear-engaging plungers. The coupler head is free to pivot to a larger degree without resistance, even when the train is in a compressed slack state.<sup>7</sup> These nonalignment control coupler-equipped

**Figure 3.** Coupler without alignment control.

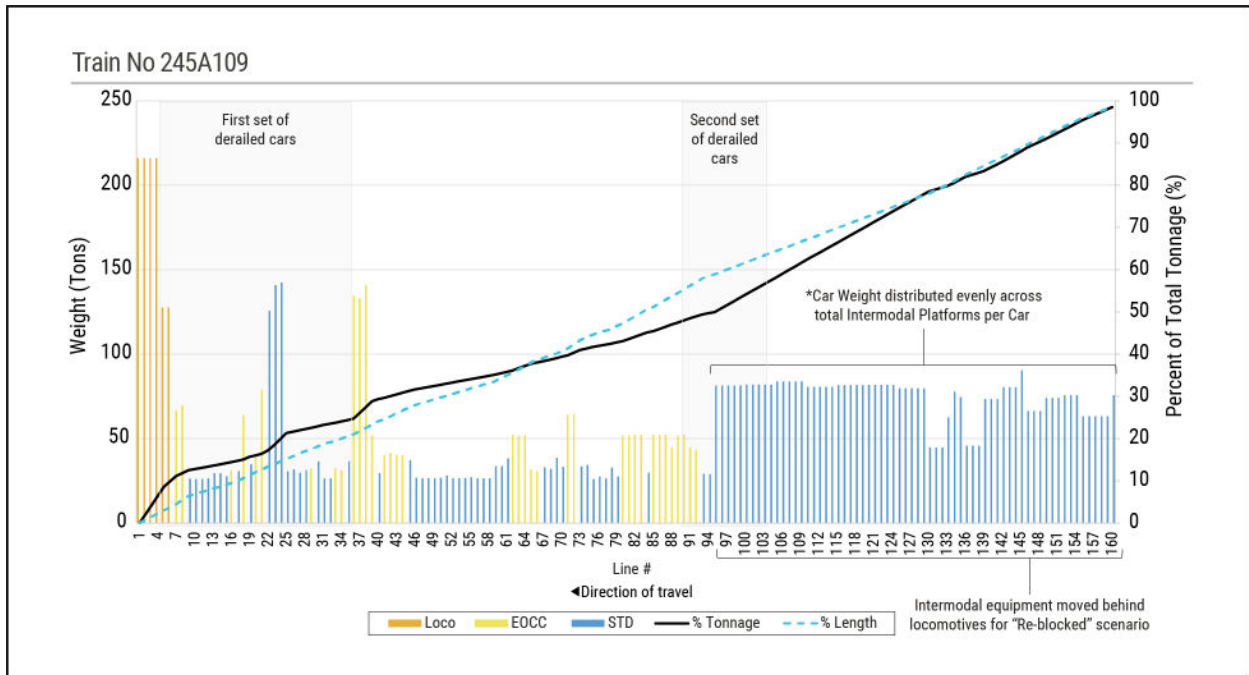
Train 245A109 consisted of 108 railcars behind the locomotive consist, weighed 9,175 tons, and was 9,769 feet long. The train consist had two distinct parts, a manifest portion, and an intermodal portion. (See figure 4.)

**Figure 4.** Graphical depiction of the train consist. Note the 20 intermodal cars on the rear of the train have been broken down into their individual segments.

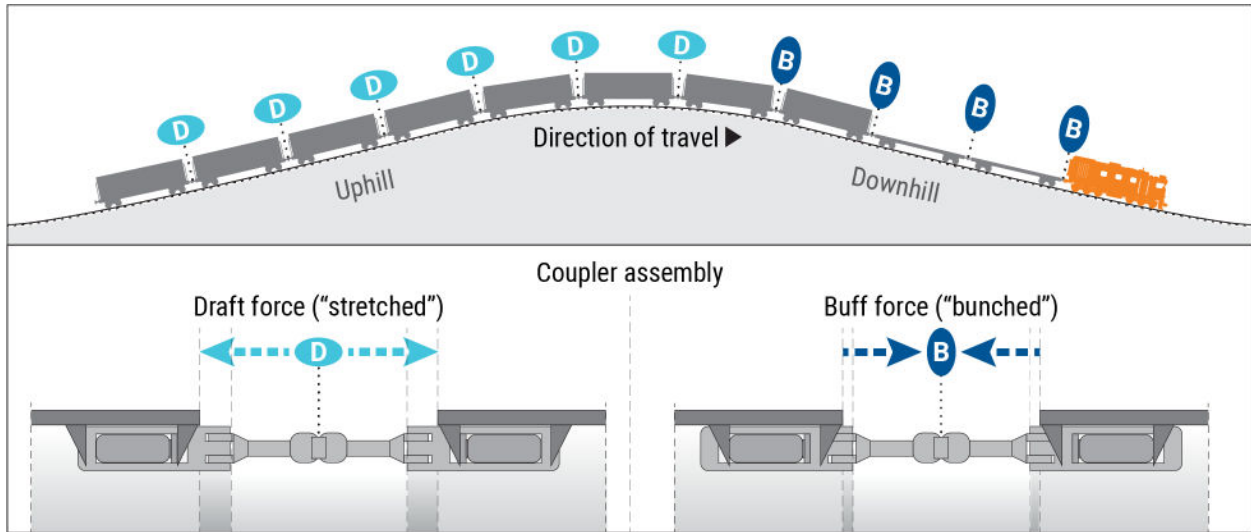
the train crests a grade and begins traveling downhill, the heavy rear railcars begin descending more quickly than the front of the train and compress the spring. (See figure 5.)

**Figure 5.** Train dynamics over the crest of a hill.

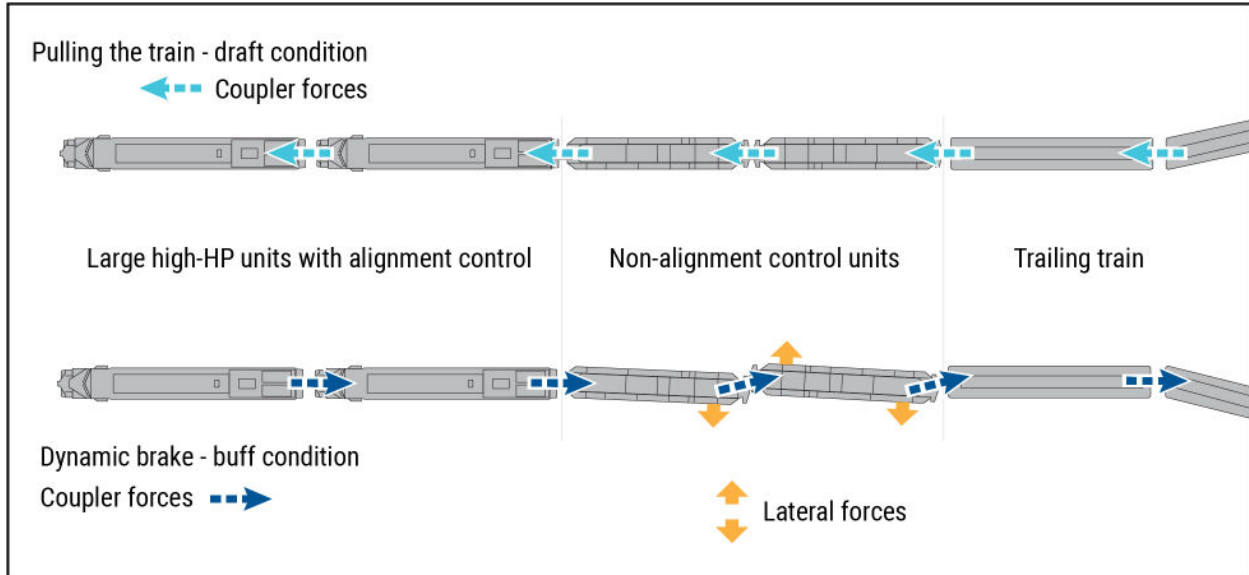
**Figure 6.** NTSB depiction of a *Railway Age* graphic showing the differences in how a train is pulled in draft condition as compared with buff condition.

by NS rules. Therefore, the two locomotives coupled together could still be at risk to jackknife, leading to a rail-rollover event. (See figure 6.)
