Railroad Investigation Report RIR-24-10

# CSX Transportation Employee Fatality

Walbridge, Ohio

September 17, 2023

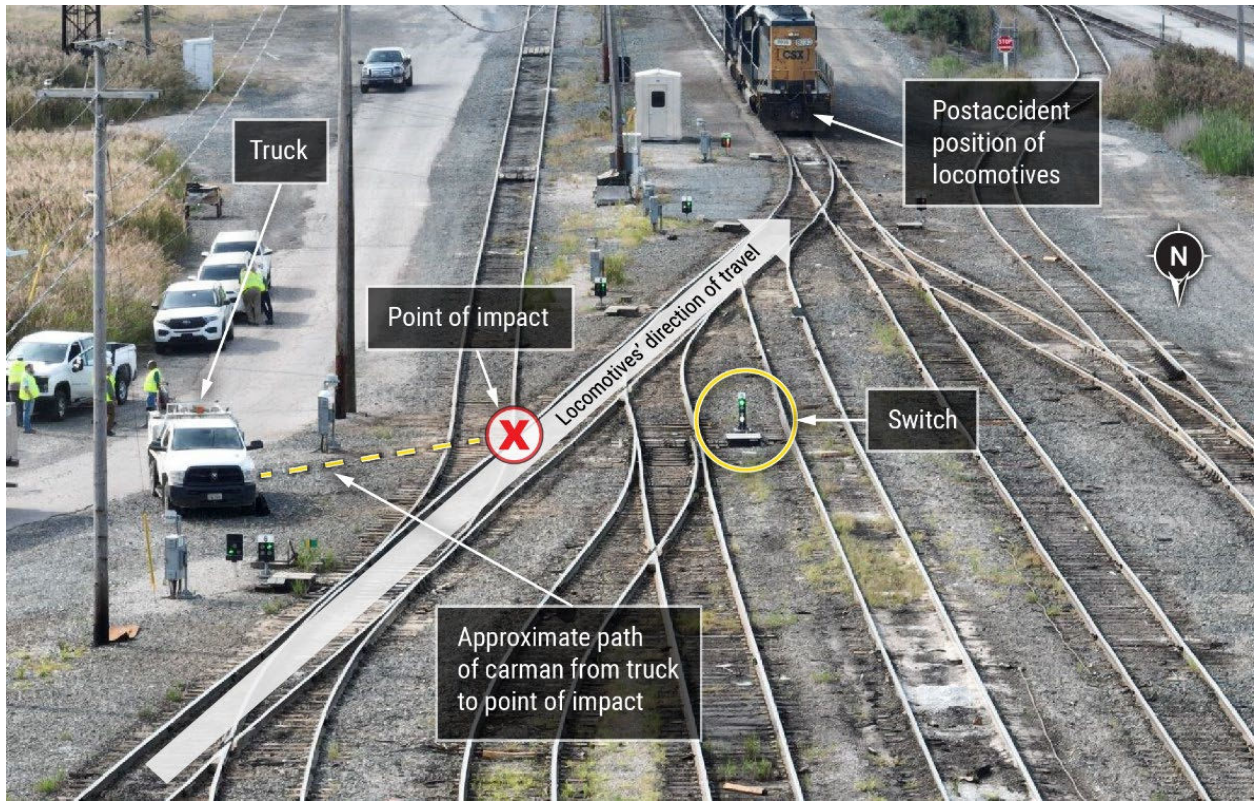
On September 17, 2023, about 3:24 a.m. local time, a member of a CSX Transportation (CSX) mechanical department crew (the accident carman) was struck and killed by a pair of remote-control locomotives during switching operations in a remote-control zone (RCZ) on the Walbridge Yard lead track in Walbridge, Ohio.<sup>1</sup> At the time of the accident, the accident carman was walking across multiple tracks to line and lock a switch to prepare for railcar inspections.<sup>2</sup> The locomotives were operating as yard job Y397 and were being used to perform switching operations under the control of a single remote-control operator (referred to as a conductor in this report) positioned on the lower ladder on the west side of the trailing locomotive. As the accident carman began crossing the lead track to access the switch, he was struck by the locomotives, which were traveling south about 10 mph. (See figure 1.) Visibility conditions at the time of the accident were dark and clear, but the area was illuminated with overhead lighting. The temperature was 63°F with no precipitation.

**Figure 1.** Accident scene. (Source: CSX.)

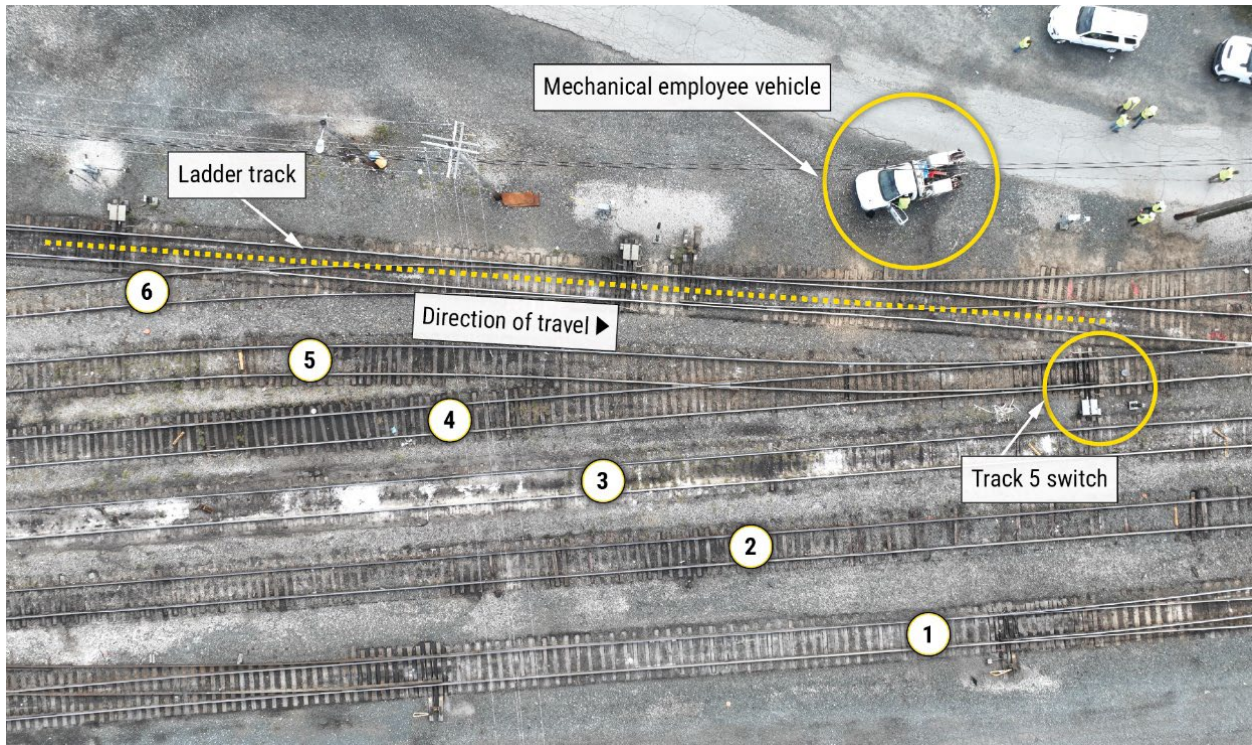
**Figure 2.** Aerial view of the tracks.
