## Illustrated Digest

# Norfolk Southern Railway Derailment and Subsequent Hazardous Materials Release

**East Palestine, Ohio • February 3, 2023**

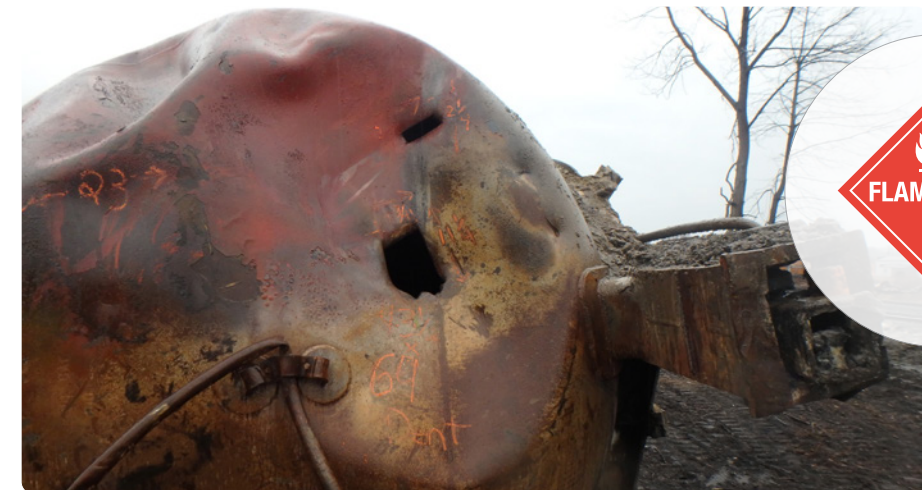
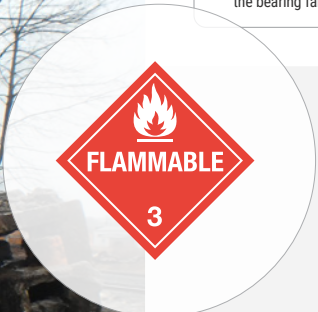
Punctured DOT-111 tank car that released butyl acrylates, a flammable liquid, likely starting the postderailment fires.

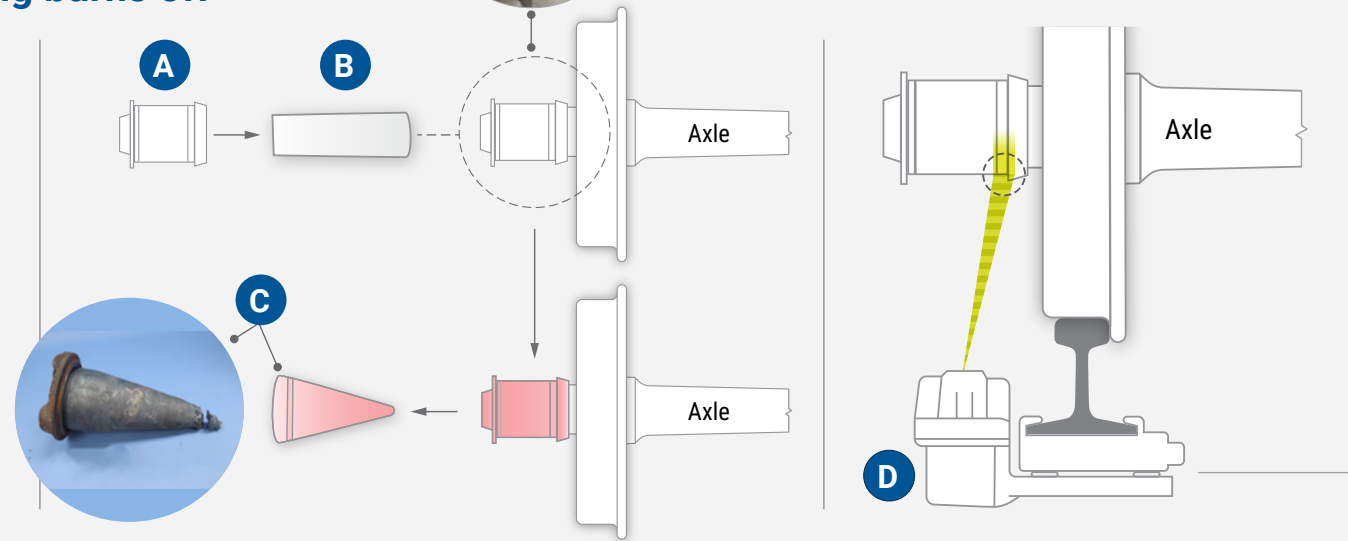
### The undetected hot bearing burns off

1. HBDs (D) measure the temperature on the outside of the bearing cup. When a bearing heats up inside, it may take 30-60 minutes for the HBD to sense it from the outside. The HBD in Salem measured a temperature of only 103° above ambient, despite the fact that the bearing was on fire. So, it generated an alert to the Wayside Help Desk, not an alarm to the train crew.

2. By the time the alarm sounded at the East Palestine HBD, the journal was worn down to a cone, and it was too late. The hopper car and 37 others derailed as the train's emergency braking system activated.

Bearings can go from below-alarm temperature to seized in less than a minute. In this accident, however, fire was first photographed near the L1 bearing by a surveillance camera in Salem, Ohio (right), 39 minutes before the train derailed in East Palestine.

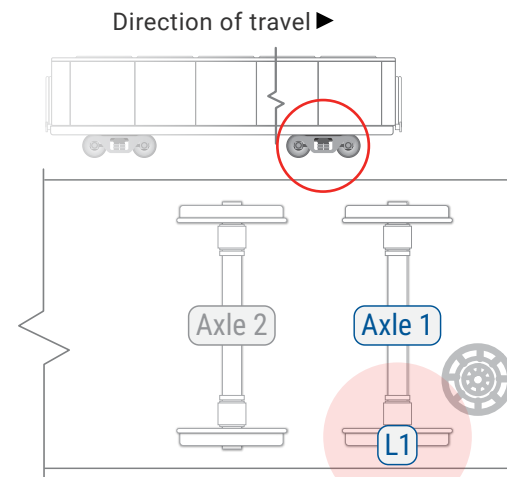
#### The L1 bearing

The bearing that caused the accident hopper car to derail was its L1 bearing, which is on the right side of the car, facing the direction of travel.

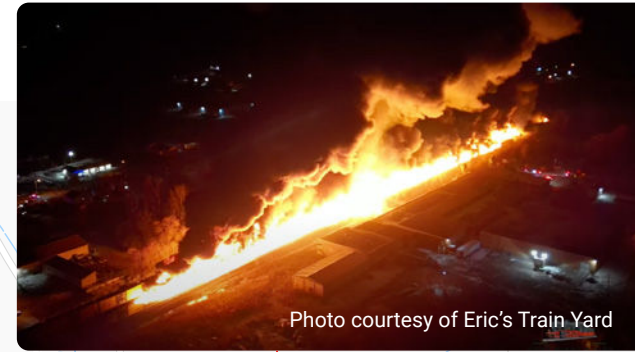
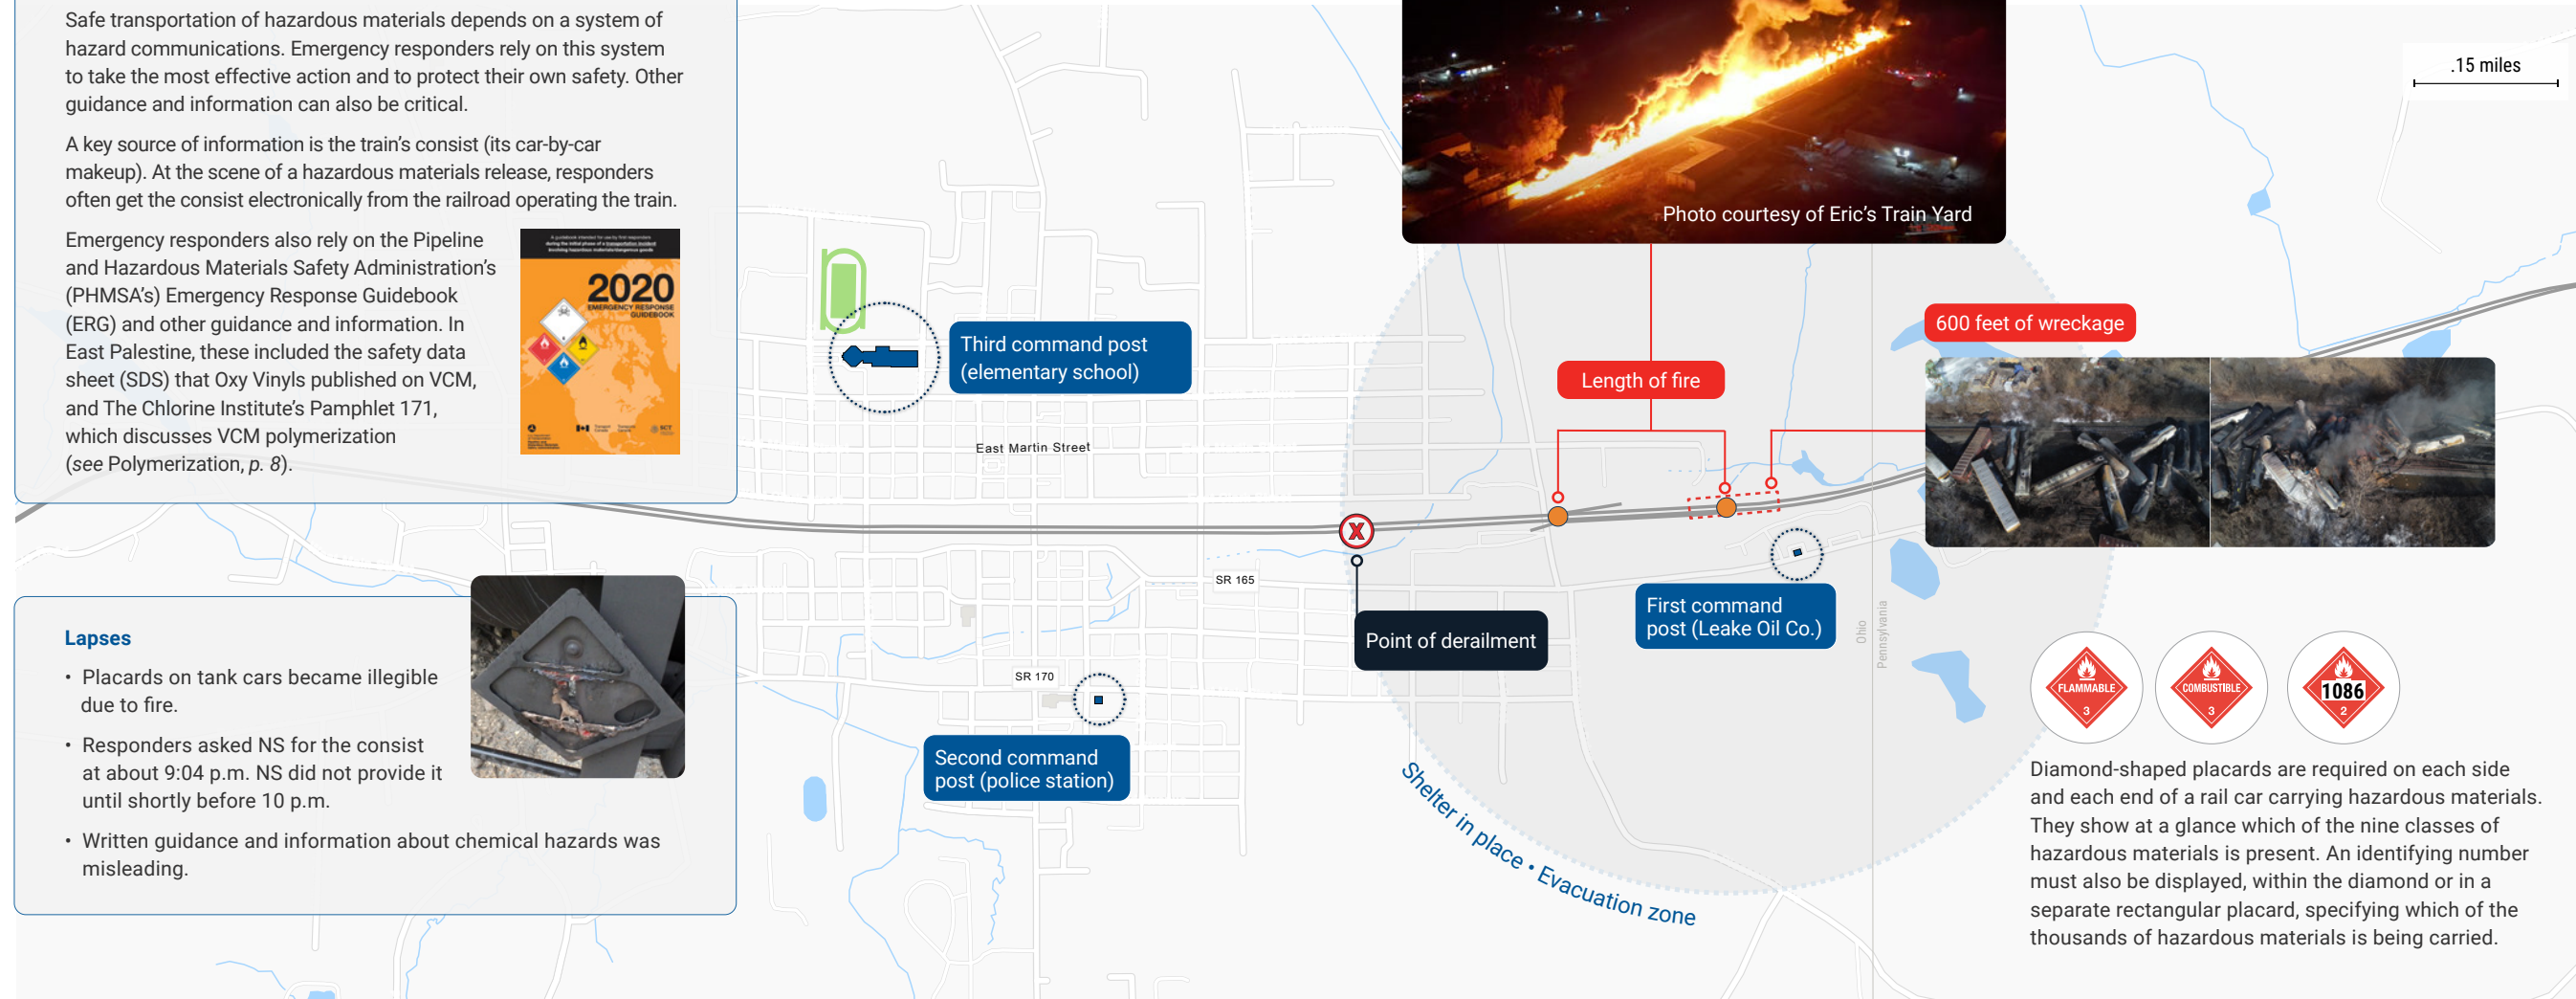
- Placards on tank cars became illegible due to fire.
- Responders asked NS for the consist at about 9:04 p.m. NS did not provide it until shortly before 10 p.m.
- Written guidance and information about chemical hazards was misleading.

Diamond-shaped placards are required on each side and each end of a rail car carrying hazardous materials. They show at a glance which of the nine classes of hazardous materials is present. An identifying number must also be displayed, within the diamond or in a separate rectangular placard, specifying which of the thousands of hazardous materials is being carried.

- Make hazardous materials placards able to survive accidents and fire.

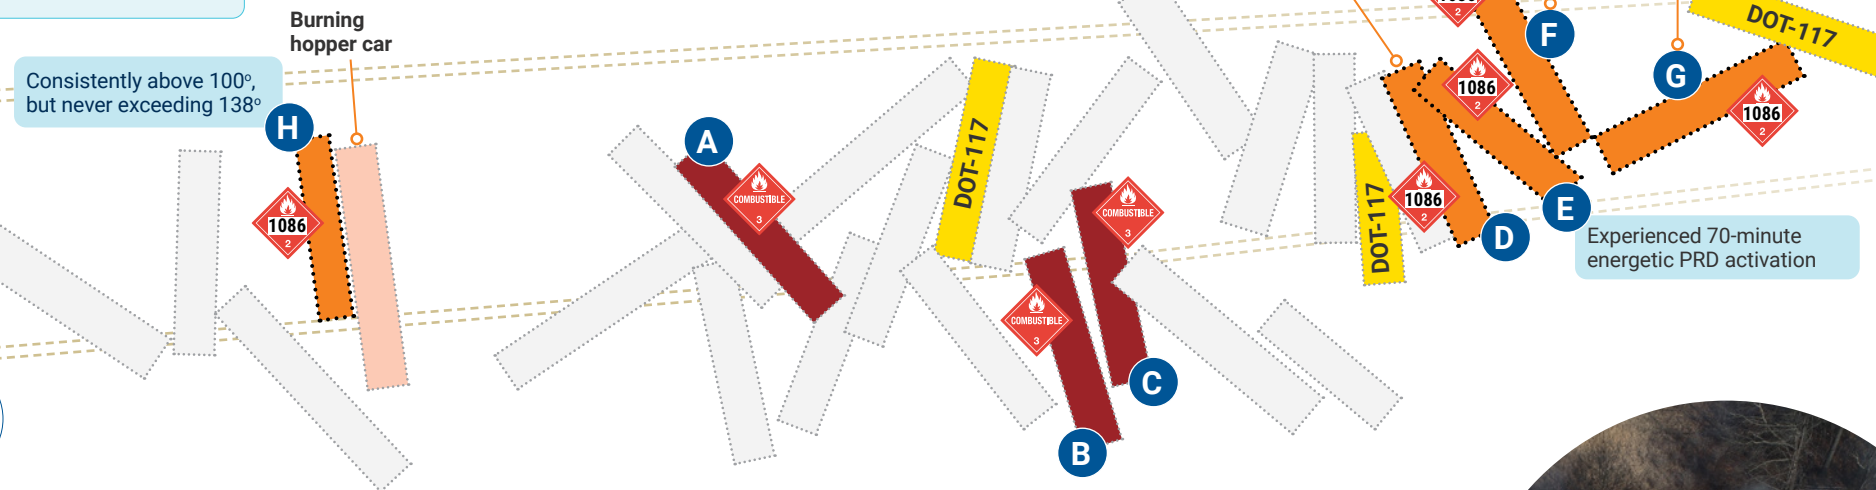
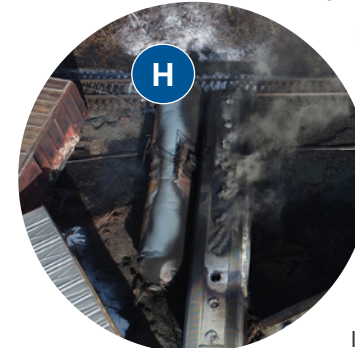
## What happened to each derailed car

At right, you can see the fate of the derailed cars. All of the DOT-117 (yellow, black labels) tank cars resisted damage and did not spill their contents. Three DOT-111 tank cars (A-C) did release their flammable and combustible contents through punctures and/or cracks from the derailment, releasing flammable or combustible liquids.

Five DOT-105 cars carrying VCM (D-H) survived the derailment without punctures or tears but contractors vented and burned their contents 3 days later. Four of them had withstood fires without cracks or punctures, even though their PRDs activated and vented some contents.

The initial 2- to 3-hour pool fire that burns in the ditch alongside the derailment is likely fueled by butyl acrylates from tank car (A) in the diagram. Other candidates include the two other red tank cars in the diagram, which carry combustible liquids (B and C).

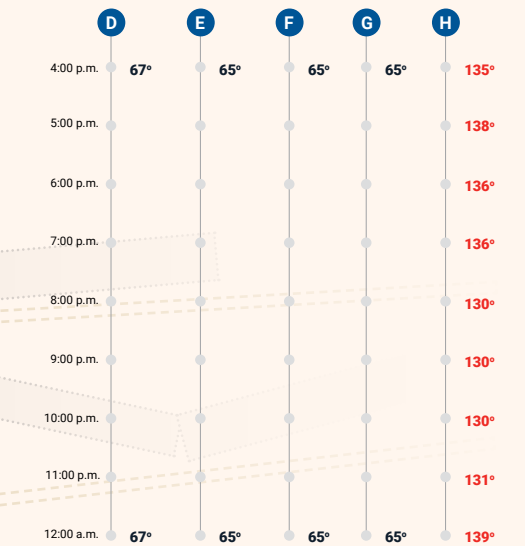
### Tank car temperatures, February 5

The temperatures of the five cars, measured on February 5 and 6, do not approach the 185 °F that caused the initial PRD actuations, and temperature trend was even declining (see charts at right).

Most temperatures were in the 60s—room temperature. Other than the VCM tank car at the western edge of the pileup (H), only two readings, both at 7:00 a.m. February 6, were warmer; one was 90° and another was 115°. After that time, only tank car (H) was warmer than room temperature. No car was warmer than 139°.

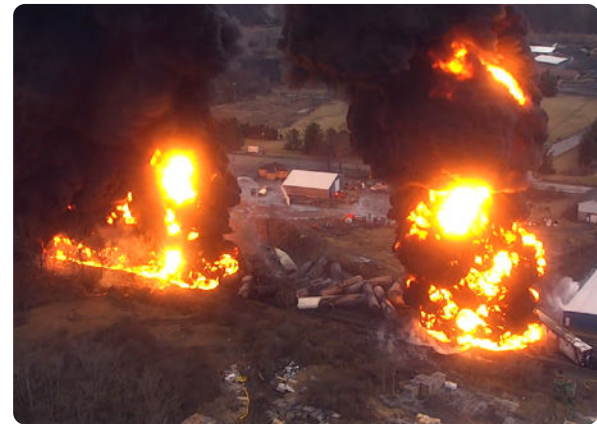
## Contractors detonate explosives, releasing and burning VCM

Contractors breached the five tank cars at 4:47 p.m. Contractors positioned flares near each tank car to ignite vapor as it was expelled. Burning VCM resulted in a column of black smoke that grew into a persistent cloud. According to the NS system manager for hazardous materials, the cloud likely contained soot particles, carbon dioxide, carbon monoxide, hydrogen chloride, and a trace of phosgene (a toxic gas).
