Railroad Investigation Report: RIR-24-12

# Union Pacific Railroad Train Collision

Chico, Texas  
April 16, 2023

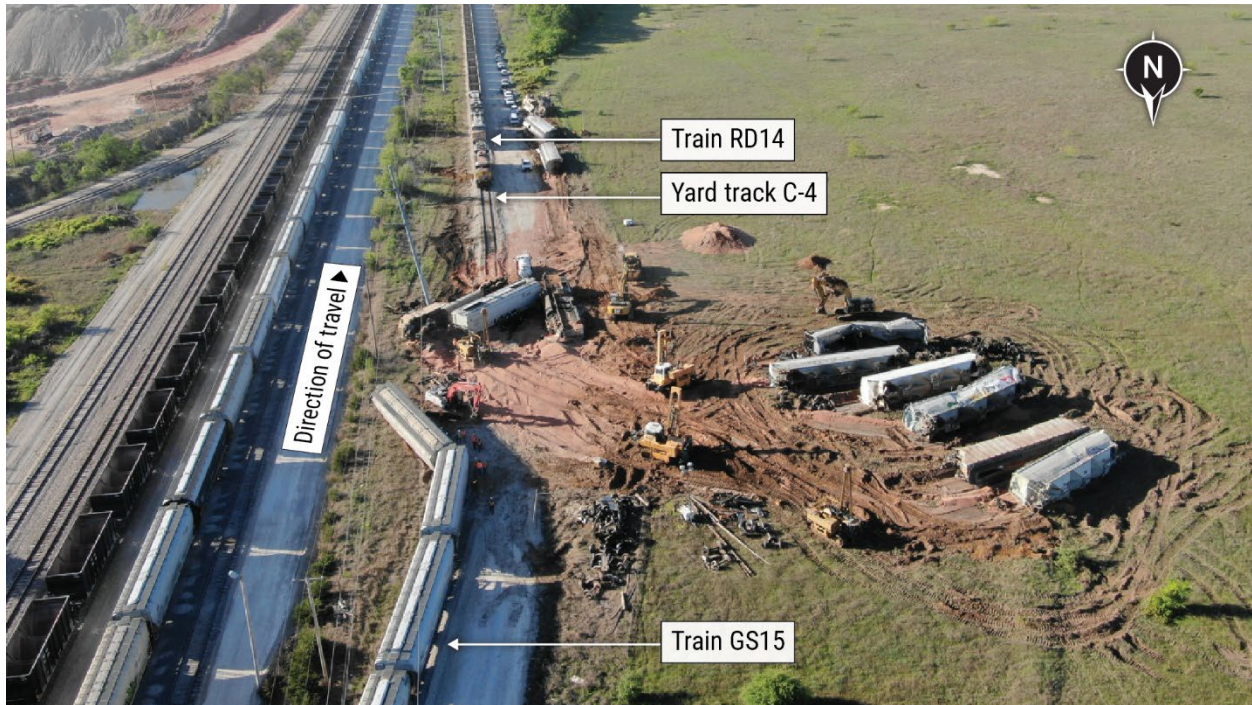
On April 16, 2023, about 6:44 p.m. local time, southbound Union Pacific Railroad (UP) train GSHFCC 15 (train GS15) crossed a main track switch lined toward yard track C-4 and collided with parked UP train RDACO 14 (train RD14) in Chico Yard in Chico, Texas.<sup>1</sup> (See figure 1.) As a result of the collision, 12 loaded hopper railcars and 2 locomotives from train GS15 derailed, and 1 empty gondola railcar and 2 locomotives from train RD14 derailed. Two crewmembers from train GS15 were seriously injured. UP estimated damages to equipment and track infrastructure to be about \$4.9 million. Visibility conditions at the time of the accident were daylight and clear, and the temperature was 68°F with no precipitation.

**Figure 1.** Aerial view of the collision scene. (Courtesy of UP.)

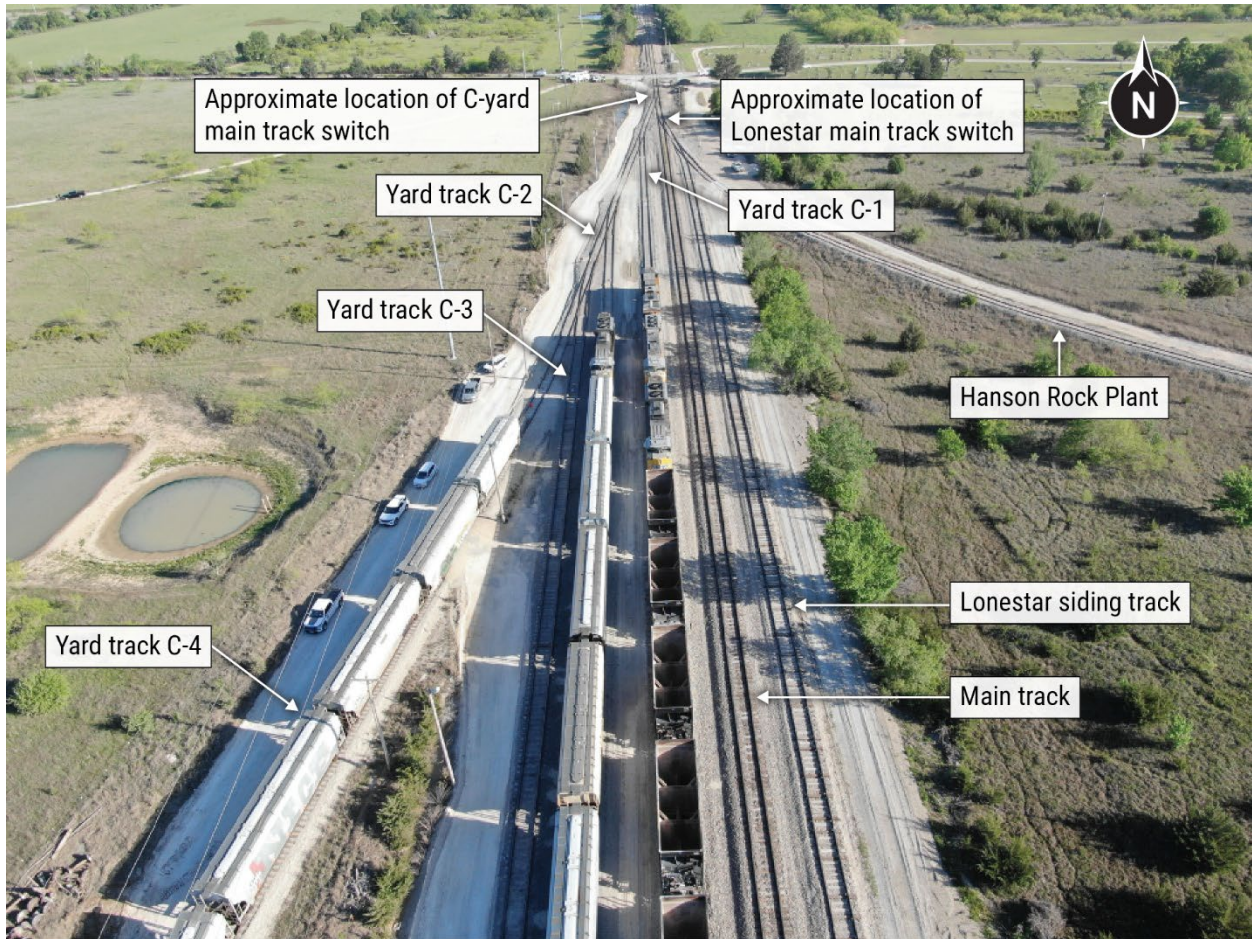
Shortly after the train RD14 crew released their warrant, about 4:37 p.m., the dispatcher issued a track warrant to the crew of train RHKPHQ 15 (train RH15), an engineer and a conductor, to proceed from Lola (a milepost location) to MP 562. The train RH15 crew lined several switches in the Chico Yard, including the Lonestar main track switch (a switch near the C-yard main track switch), to park their train in the Hanson Rock Plant. During this movement, the crew did not use the adjacent C-yard main track switch or C-yard tracks. Figure 3 shows the approximate location of the C-yard main track switch, the C-yard tracks, the main track, the approximate location of the Lonestar main track switch, the Lonestar siding track, and the Hanson Rock Plant.

**Figure 3.** Aerial view of the area where the collision occurred. (Courtesy of UP.)

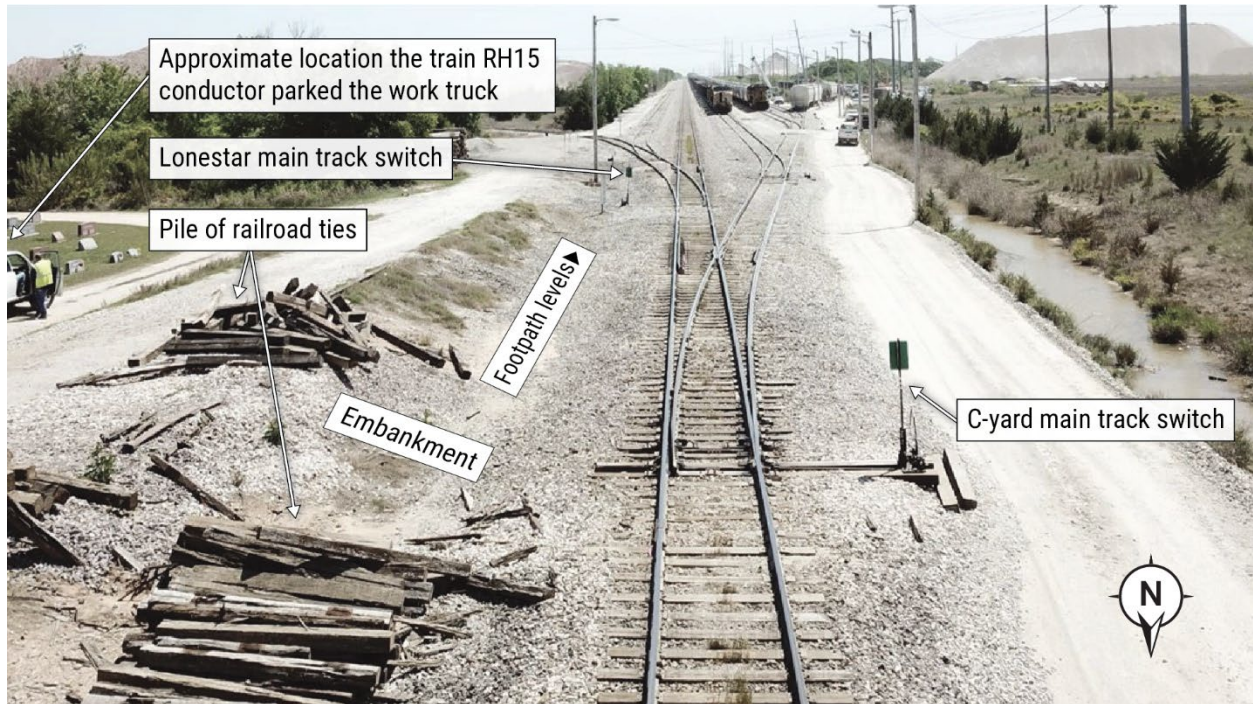
During postcollision site examinations 2 days after the accident, the NTSB saw a pile of railroad ties and an embankment (incline) across from the C-yard main track switch. The NTSB also saw that the footpath was level near the Lonestar main track switch. In addition, the NTSB noted the approximate location the train RH15 conductor parked the work truck when he went to reline the Lonestar main track switch. (See figure 4.)

**Figure 4.** Photograph of the C-yard and Lonestar main track switches and the surrounding area. (Courtesy of UP.)

The crew lined the Lonestar main track switch away from the main track to park their train in the Hanson Rock Plant. When the conductor went by himself to restore the Lonestar main track switch, he walked downhill and lined a switch across from a pile of railroad ties and a downward-sloping embankment, a location consistent with the C-yard main track switch, not the Lonestar main track switch. (The Lonestar main track switch was in a flat area with no railroad ties nearby, about 135 feet south of the C-yard main track switch.) The conductor likely lined the C-yard main track switch away from the main track and toward yard track C-4 when he intended to restore the Lonestar main track switch.
