RAIL TRANSPORTATION SAFETY INVESTIGATION REPORT R24C0020

MAIN-TRACK TRAIN COLLISION

Canadian Pacific Railway Company, doing business as CPKC
Freight trains 805-339 and 301-230
Mile 116.8, Mountain Subdivision
Near Greely, British Columbia
16 February 2024

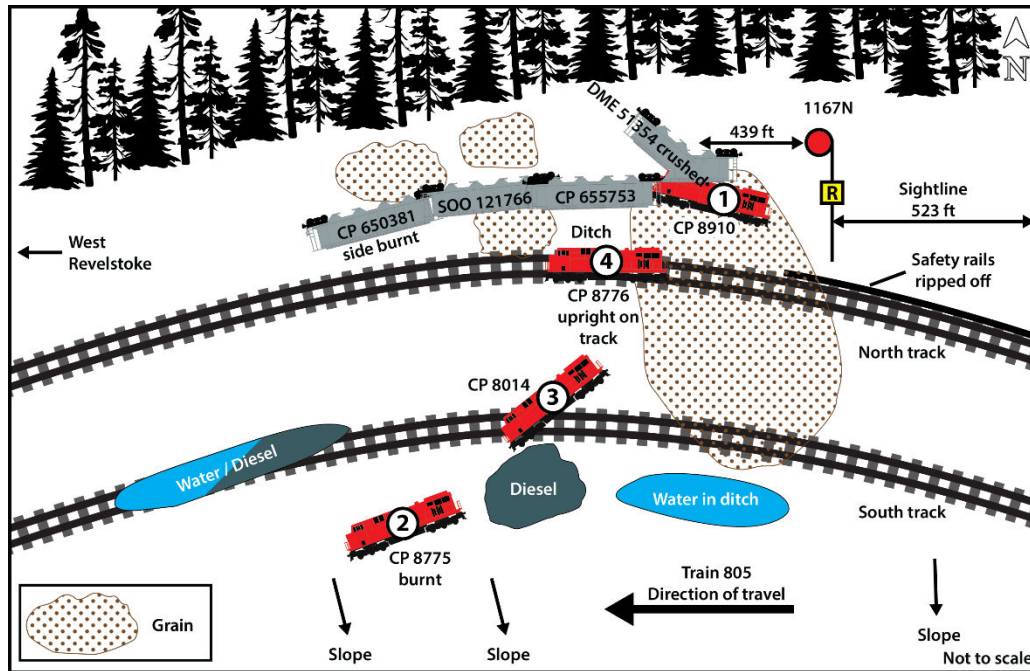
As a result of the collision, the 4 head-end locomotives on train 805 derailed (locomotives CP 8910, CP 8775, CP 8014, and CP 8776), 1 of which (CP 8775) caught fire. About 17 500 litres of diesel fuel leaked from the derailed locomotives. On train 301, 4 cars derailed, 1 of which (CP 650381) caught fire, and about 400 tons of grain spilled from the train (Figure 2).

Figure 2. Schematic of the occurrence site showing the derailed rolling stock after the collision, including the derailed locomotives and their order in the train consist (Source: TSB)

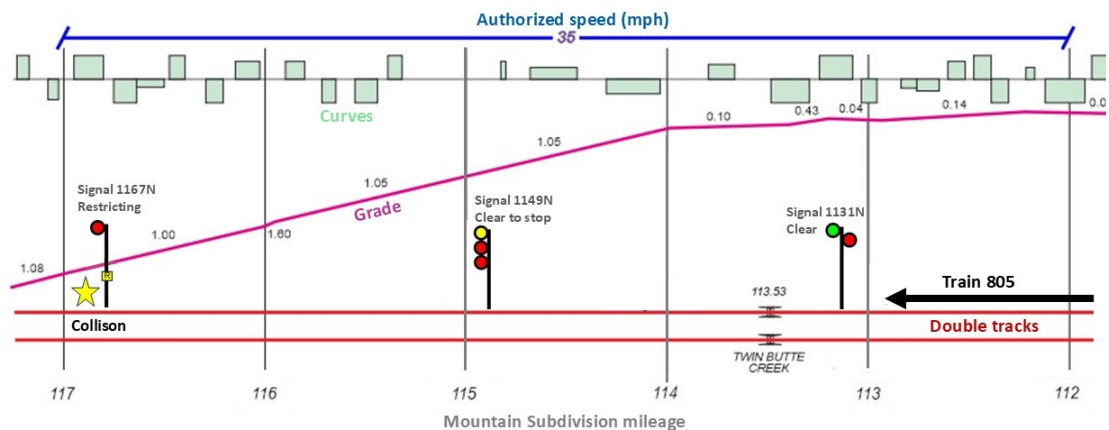
- The 1st signal, 1131N, displayed a Clear indication, which identified that the train could proceed.
- The following signal, 1149N, displayed a Clear to Stop indication, which identified that the train could proceed but must be prepared to stop at the next signal. CPKC's *Rule Book for T&E Employees* also stipulates that, on a Clear to Stop indication, movements must reduce to a speed not exceeding 30 mph (40 mph for passenger trains).¹⁴
- The 3rd signal, 1167N, displayed a Restricting indication, which identified that the train could proceed at restricted speed.

Figure 3. Schematic of the signal progression in this occurrence (Source: CPKC, with TSB annotations)
