Collision of Two Washington Metropolitan Area Transit
Authority Metrorail Trains Near Fort Totten Station
Washington, D.C.
June 22, 2009

Railroad Accident Report

NTSB/RAR-10/02
PB2010-916302

National
Transportation
Safety Board

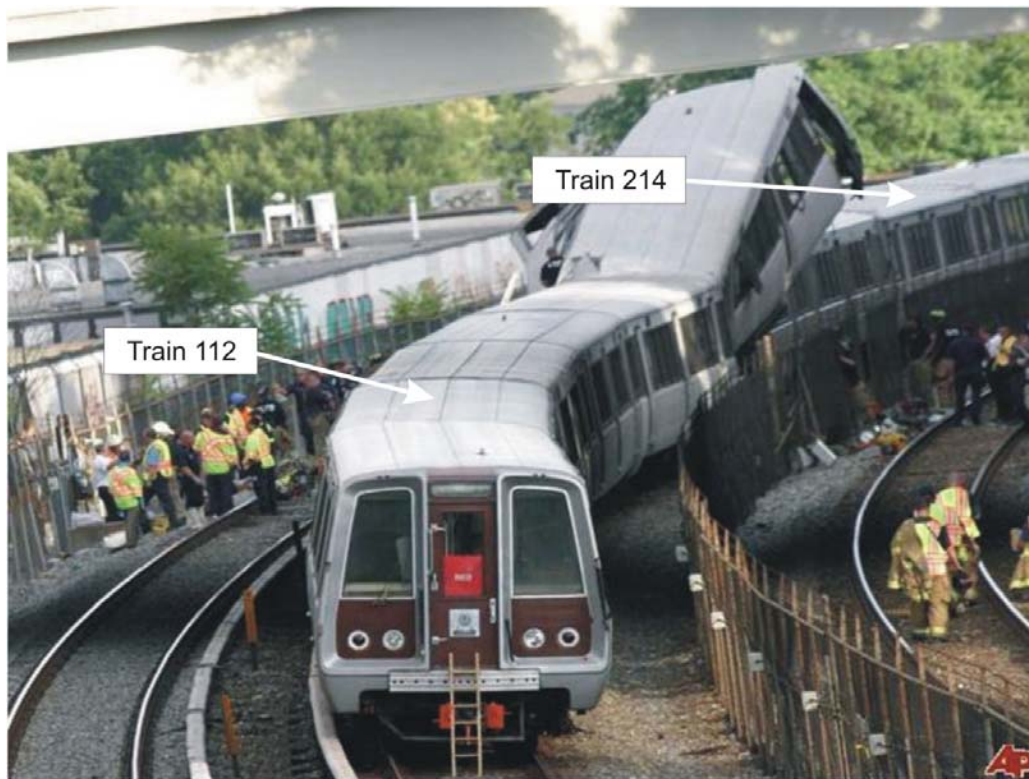
Figure 1. Lead car of striking train (train 112) has overridden last car of struck train (train 214), which has telescoped into lead car of train 112.

The accident occurred on a segment of curved track and resulted in the derailment of the first car and the lead axle of the second car of the striking train. The lead car also sustained catastrophic carbody intrusion damage (telescoping) and loss of occupant survival space to a distance of about 63 feet (about 84 percent of its total length). The rear car of the struck train did not sustain extensive damage and did not derail. None of the other cars on the two trains derailed or sustained major damage. Damage to the train equipment was estimated to be \$12 million.

Most of the damage from the collision was sustained by the lead car of train 112. Both cars came to rest upright and substantially aligned with the track. The lead and second cars of the striking train derailed; these were the only cars on either train to do so. The other railcars of each train were wedged together but were otherwise substantially undamaged and did not lose any occupant survival space. No evidence of fire was apparent in any of the railcars, nor was there evidence of release of a hazardous material such as battery acid.

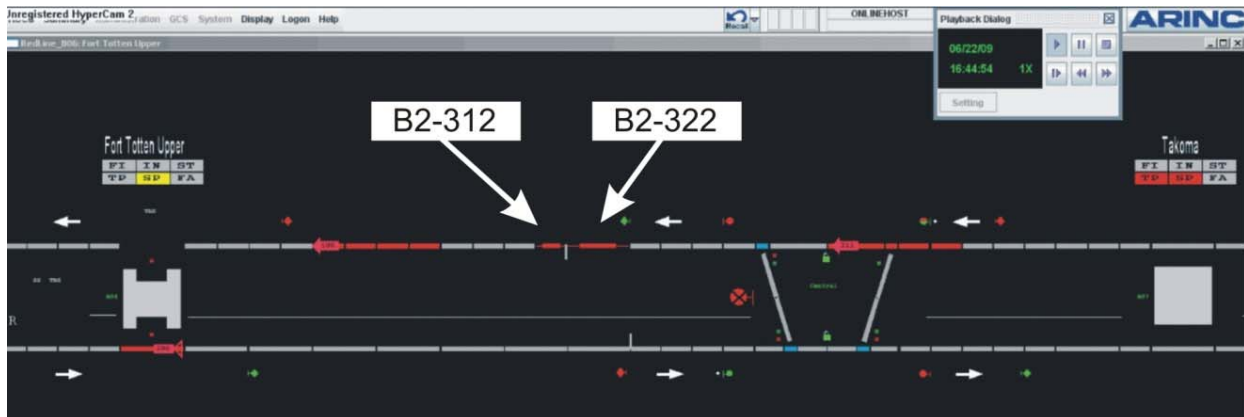
Figure 7. Example of Advanced Information Management controller display showing status of signals, interlockings, track circuit occupancies, and train movements between Fort Totten and Takoma stations. Contiguous solid red blocks indicate presence of a train. (Icons for track circuits B2-312 and B2-322 indicate that these track circuits are reporting as occupied without a train present.)

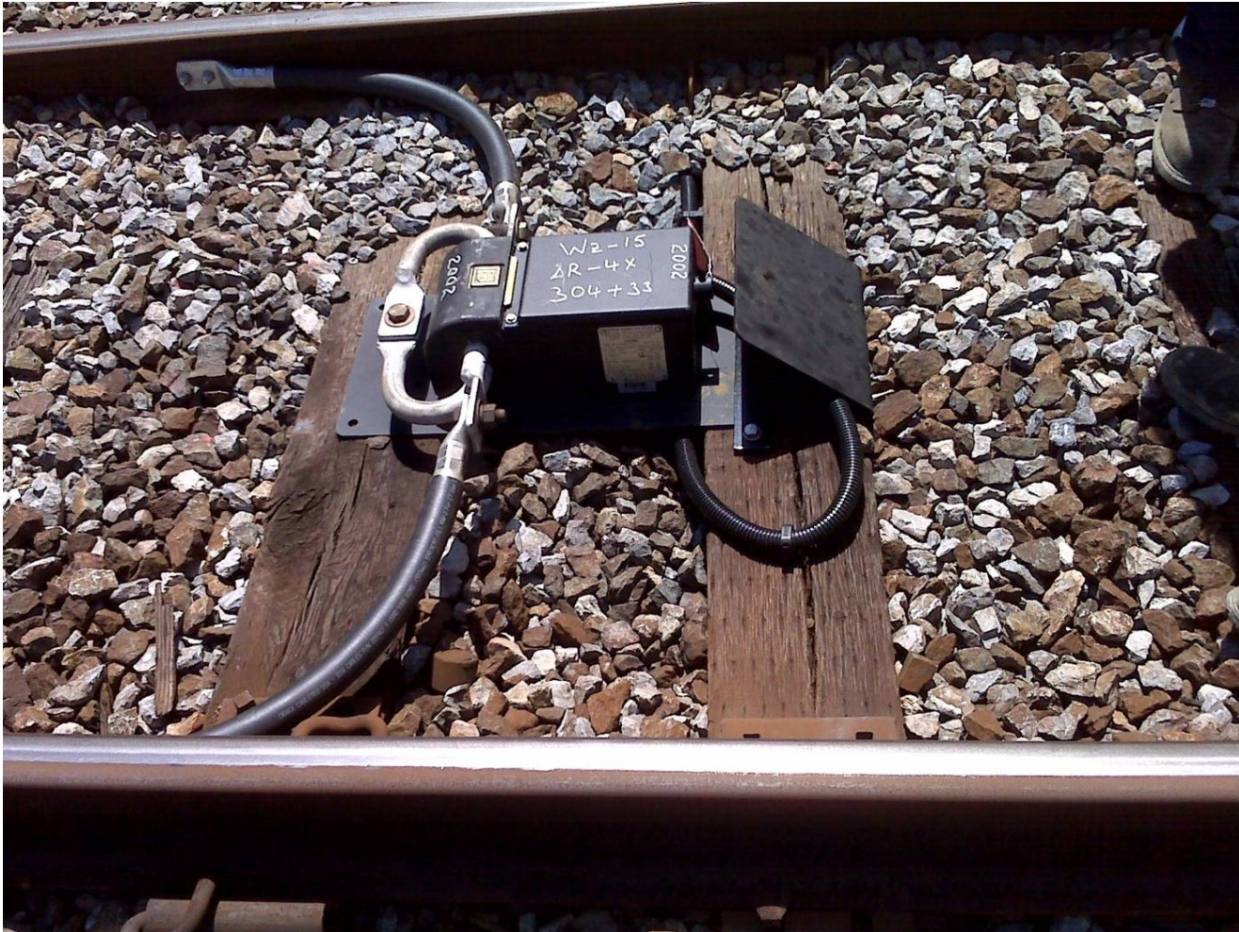
Figure 8. Impedance bond for track circuit B2-304.

Track occupancy detection is accomplished as follows: At each end of each track circuit, an impedance bond is mounted between the rails. (See figure 8.) The impedance bond at one end of the block acts as a transmitter; the one at the other end acts as a receiver.⁵⁰ Track circuits are typically arranged for the normal direction of traffic so that a train entering a track circuit will pass over the receiver end of a track circuit before traversing the transmitter end.

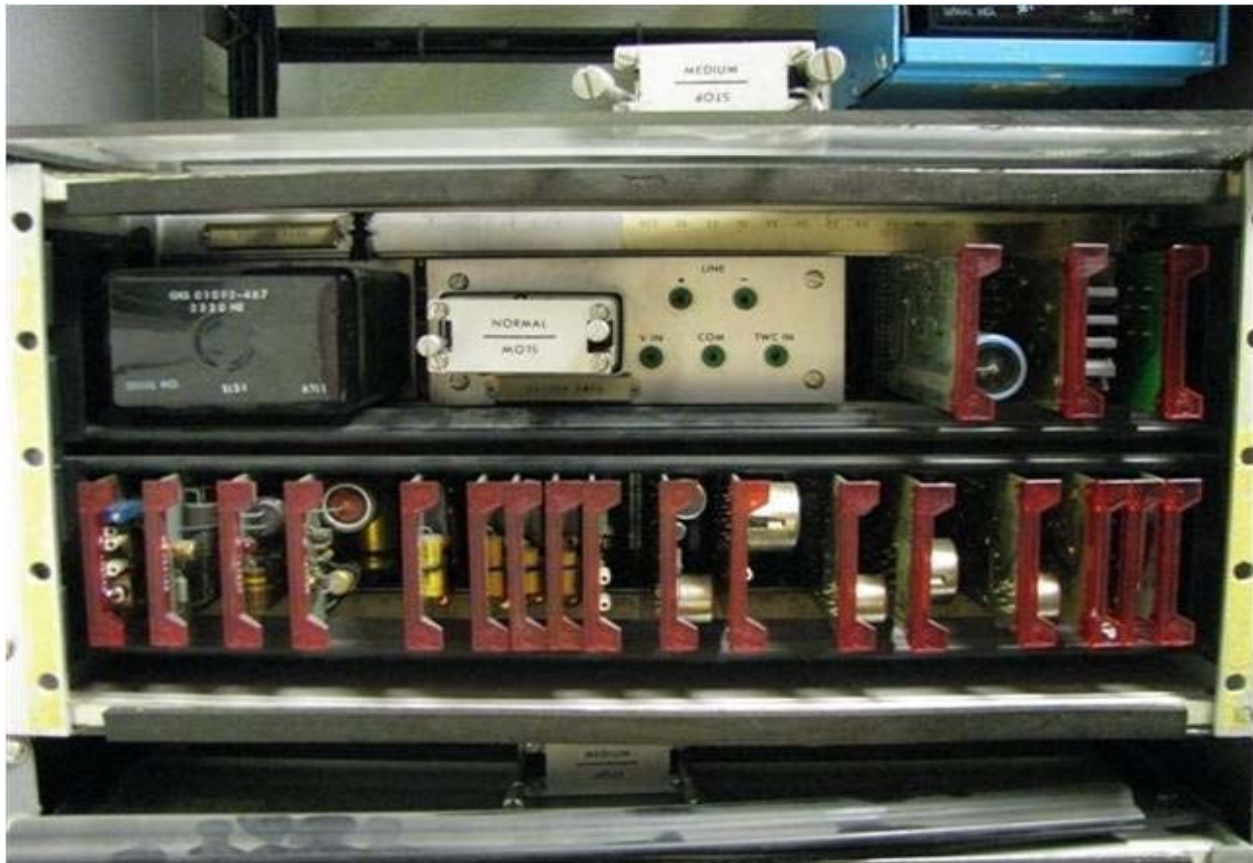
Figure 9. Typical track circuit module.

a track circuit receiver module in the train control room. (See figure 9.) The track circuit receiver module filters, amplifies, and checks the level of the signal it receives from the impedance bond. If the signal meets the amplitude and modulation requirements for that track circuit, the module energizes the coil of a track relay. The energized coil causes the relay armature to “pick up,” or rise, thus completing the track circuit. A track relay in the “up,” or raised, position indicates to the ATC system that the block of track is unoccupied.

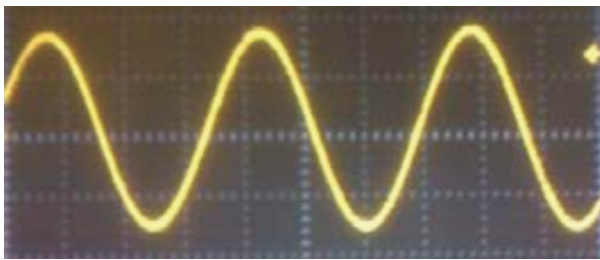
Oscillation type 1: A clean sinusoidal audio waveform.

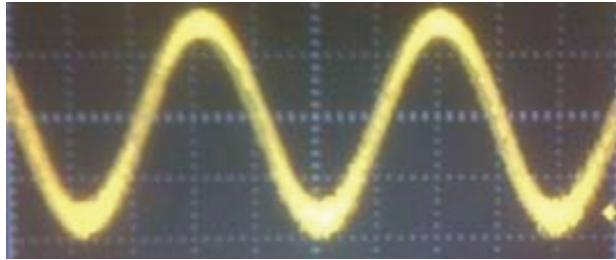
Oscillation type 2: The entire waveform appears uniformly thickened as though out of focus. Indicates a harmless and continuous oscillation at some higher frequency (25 megahertz for example).

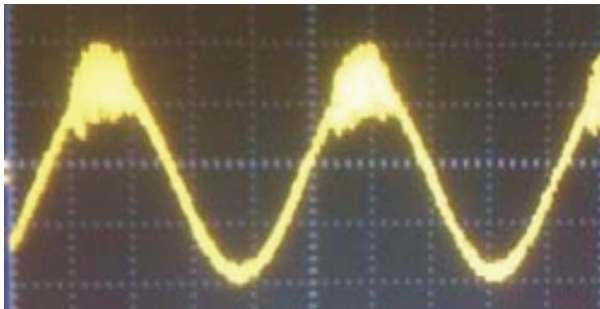
Oscillation type 3: The thickened portions of the waveform are all in the same region (usually at a positive or negative peak), indicating local (internal) oscillations. The track circuit may be at risk for the parasitic oscillation failure mode.

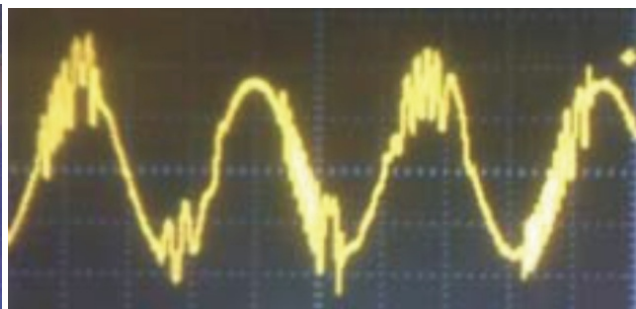
identified as having type 4 oscillation like that found at Fort Totten used GRS impedance bonds and GRS track circuit modules.

Oscillation type 4: The thickened portions of the waveform are irregular (they appear at different angles/locations of the waveform), indicating that they are coming from another transmitter, via the power distribution and rack structures, and are superimposed on the preamplifier of the shared track circuit transmitter. These are external oscillations that could mimic a valid track circuit signal and result in a loss of train detection.

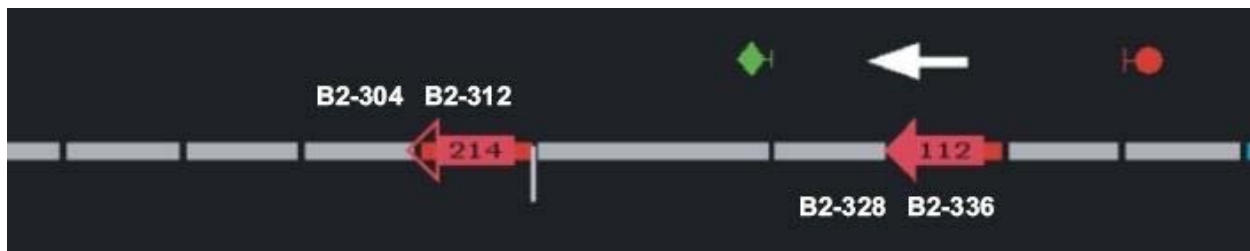
4:56:50 p.m. Train 214 is detected occupying track circuit B2-312, with train 112 several blocks behind on track circuit B2-336. Red track circuit symbols indicate track occupancy. The transparent arrowhead for train 214 indicates that the train is being operated in manual mode. Performance data indicated that the front of train 214 was actually at chain marker 315+00, corresponding to track circuit B2-312. The front of train 112 was actually at chain marker 338+48, corresponding to track circuit B2-336. The solid arrowhead for train 112 indicates that this train is in automatic mode.

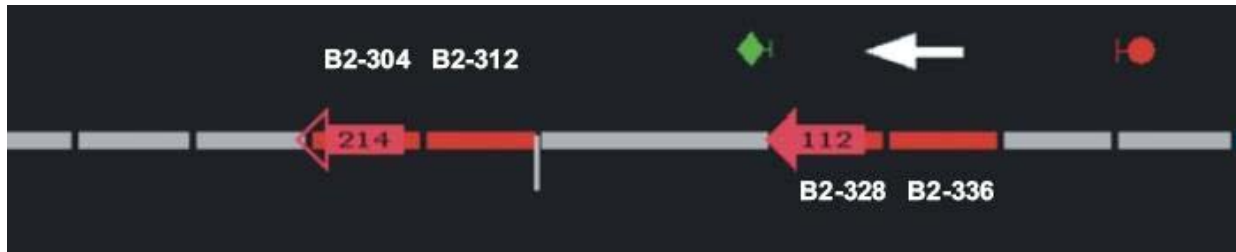
4:57:02 p.m. Both trains have moved forward into the next block in their direction of travel. Track occupancy is being detected on track circuits B2-304 and B2-312 for train 214 and on track circuits B2-328 and B2-336 for train 112. Performance data indicated that the front of train 214 was at chain marker 312+00, corresponding to track circuit B2-312. The front of train 112 was at chain marker 335+70, corresponding to track circuit B2-328.

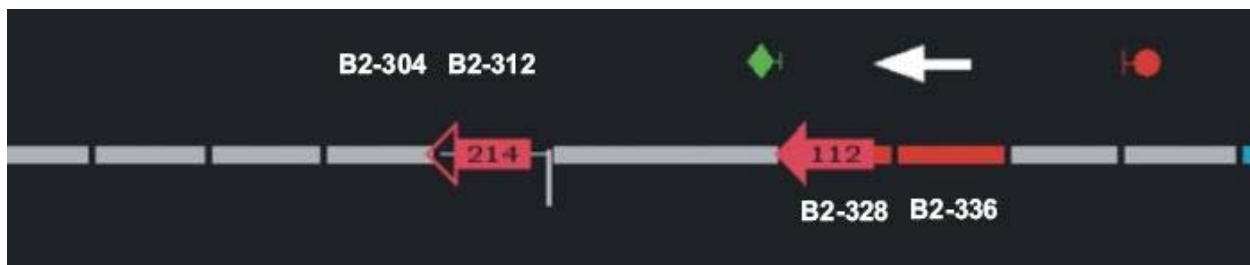
4:57:19 p.m. Train 214 is depicted as occupying a single track circuit (B2-312) that is shown as a non-reporting block (a track circuit that reports as vacant when Advanced Information Management system computer algorithms determine that it should be occupied). Track circuit B2-304 displays as an unoccupied, normally reporting block. Performance data indicated that train 214 was stopped at this time and that the front of train 214 was actually at chain marker 307+00, corresponding to track circuit B2-304. The front of train 112 was at chain marker 335+69, corresponding to track circuit B2-328. Track circuit B2-304 displays as a normally reporting, unoccupied block even though performance data indicated that train 214 was fully within that track circuit. Performance data also indicated that at this time train 112 had begun receiving speed commands of 55 mph.

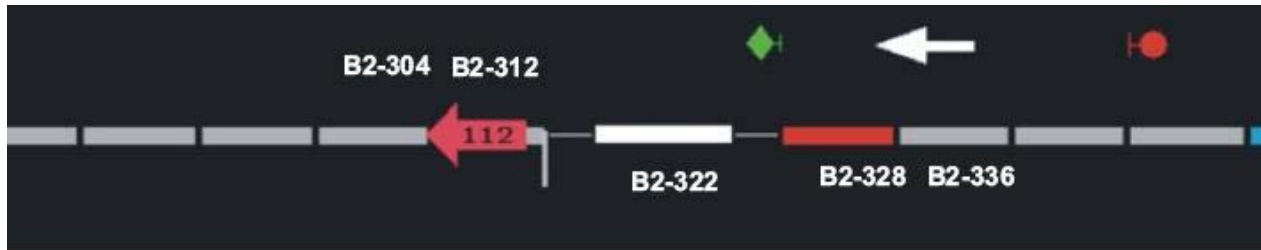
4:57:39 p.m. Train 214 is gone from the display. Train 112 is displayed as occupying a single track circuit (B2-312), which is now reporting as an unoccupied block. At this time, performance data indicated that the front of train 214 was at chain marker 307+00, corresponding to track circuit B2-304. The front of train 112 was at chain marker 329+52, corresponding to track circuit B2-328. Track circuit B2-328 is displayed as an occupied block. The intervening track circuit (B2-322) is displayed as an unoccupied, non-reporting block. Track circuit B2-304 is displayed as unoccupied even though all of train 214 is occupying that track circuit.

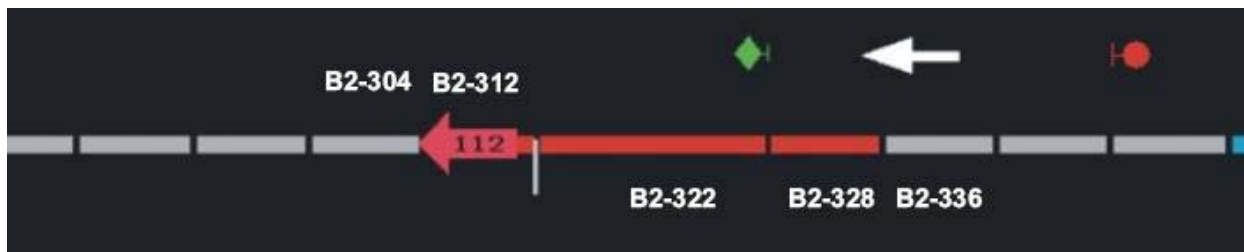
4:57:46 p.m. Train 112 is displayed as occupying three track circuits, all of which are displayed as normally reporting blocks. Performance data indicated that the front of train 214 was actually at chain marker 307+00, corresponding to track circuit B2-304. The front of train 112 was at chain marker 324+64, corresponding to track circuit B2-322.

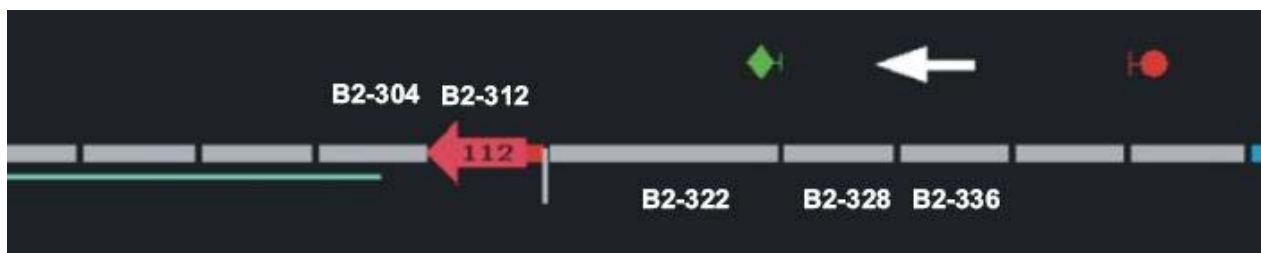
4:58:10 p.m. Train 112 is displayed as occupying a single track circuit (B2-312). All track circuits are now displayed as normally reporting blocks. The green line indicates that third-rail power is down ahead of B2-312. Performance data indicated that the front of train 214 was actually at chain marker 307+00, corresponding to track circuit B2-304. The front of train 112 was at chain marker 311+00, also corresponding to track circuit B2-304.
