Hazardous Materials Investigation Report: HZIR-25-01

BNSF Railway Derailment and Hazardous Materials Release from DOT-112A340W Tank Cars

Location	Manuelito, New Mexico
Date	April 26, 2024
Accident type	Container failure
Train	BNSF Railway freight train H-BELPHX1-25 1 conductor, 1 engineer 4 locomotives, 97 mixed freight cars
Hazardous materials	Liquefied petroleum gas (propane) shipped as UN1075
Fatalities	0
Injuries	0
Property Damage	\$5.9 million

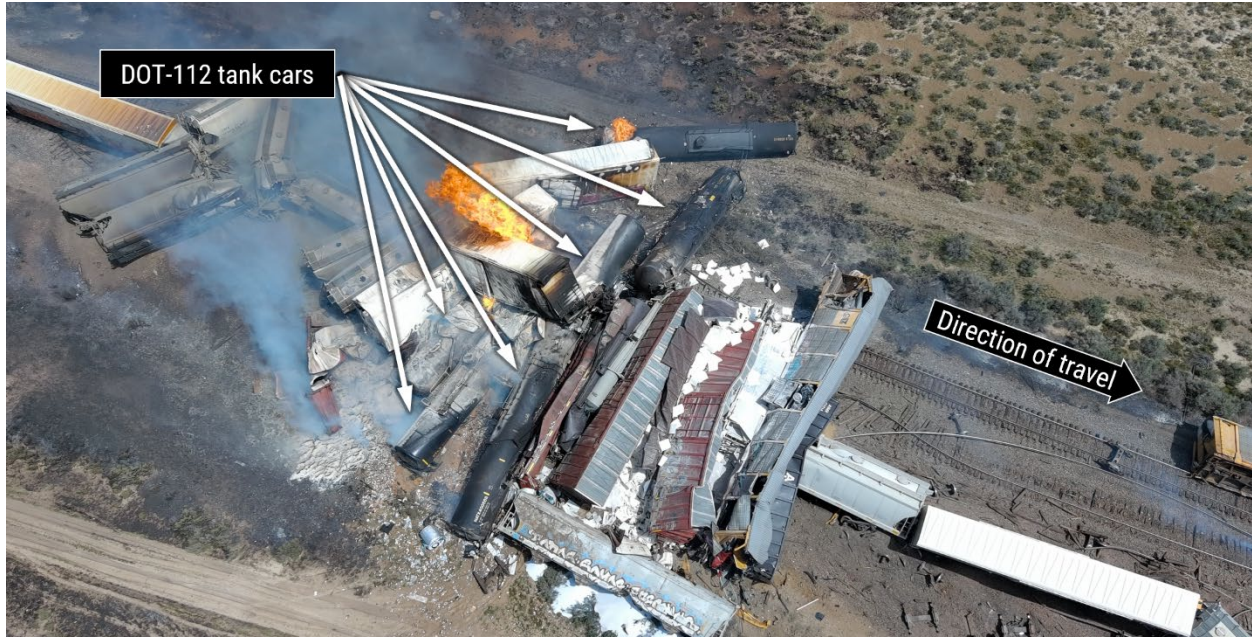
On April 26, 2024, about 12:37 p.m. local time, westbound BNSF Railway (BNSF) mixed freight train H-BELPHX1-25 derailed 35 railcars at milepost 178.6 on the BNSF Gallup Subdivision near Manuelito, New Mexico.¹ The derailed equipment included six Department of Transportation Specification 112A340W (DOT-112) tank cars loaded with UN 1075, liquefied petroleum gas (LPG), a Division 2.1 flammable gas.² Four of these tank cars were breached (punctured or torn) during or after the derailment and released lading, which ignited. A fifth LPG tank car was exposed to postderailment fires and released vapor through its pressure relief device (PRD) but was not otherwise breached. About 180,000 gallons of LPG were released from breaches, PRD activity, and flaring

Figure 1. Derailment pileup. (Courtesy of McKinley County Office of Emergency Management.)

Postaccident on-scene examinations found damage consistent with mechanical breaches (punctures or tears created by outside forces) on two tank cars: UTLX952565 and UTLX955642. For these two tank cars, the investigation found evidence of lading loss only through mechanical breaches. The released LPG ignited and contributed to postderailment fires near other derailed tank cars, including other LPG tank cars.

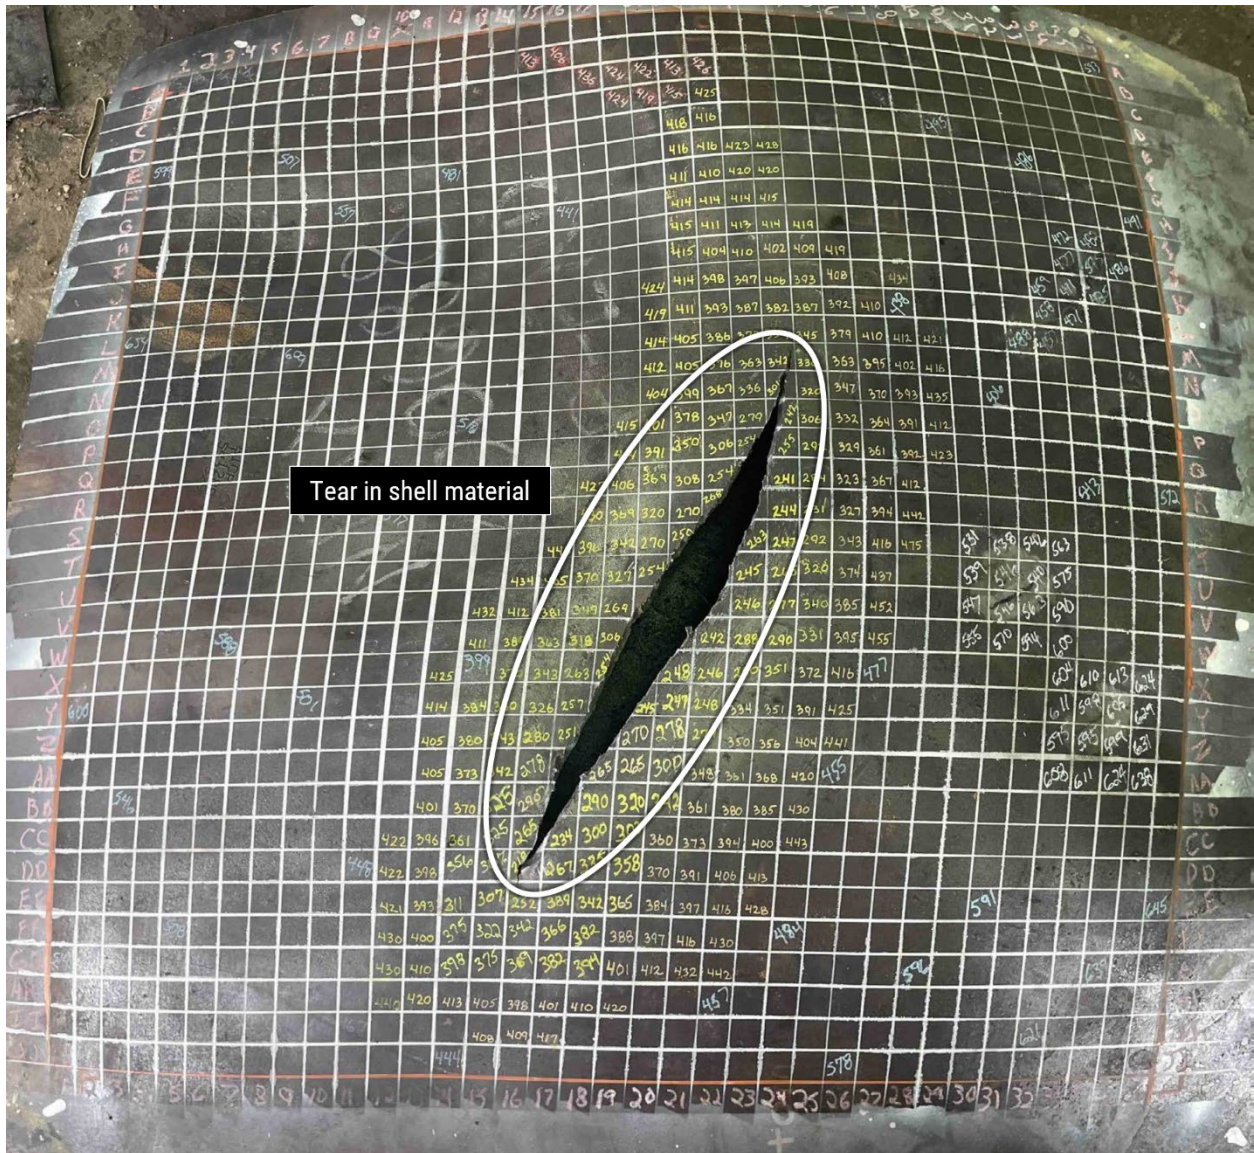
Two other derailed LPG tank cars (UTLX 954193 and NATX 40068) were not mechanically breached during the derailment but released lading from shell tears after being exposed to fire. The duration of fire exposure before these releases was not recorded. The Federal Railroad Administration (FRA) recovered the panels of tank car

shell material containing tears for examination in coordination with the NTSB. Ultrasonic measurements showed that the shell wall had thinned and cracked near the tears. (See figure 2.)

Figure 2. Tear in shell material recovered from tank car with ultrasonic thickness measurements.

The laboratory examinations found that the tears resulted from the shells thinning and cracking. This confirmed the presence of thermal tears, which occur when the pressure within a tank car exceeds the tensile strength of its shell. As the temperature of a tank car increases, the volatility (and pressure) of the lading tends to increase as the tensile strength of the steel shell and head decreases until the steel tears. The postaccident examinations and laboratory testing did not indicate that the tank car shells failed as a result of a flaw in design or fabrication.
