# Union Pacific Railroad Train Collision and Conductor Fatality

<b>Location</b>	Melrose Park, Illinois
<b>Date</b>	July 6, 2024
<b>Accident type</b>	Raking collision
<b>Striking train</b>	Union Pacific freight train MCBCH-05 2 crewmembers 1 locomotive, 45 railcars
<b>Departing train</b>	Union Pacific freight train MPRNL-06 2 crewmembers 2 locomotives, 91 railcars
<b>Track</b>	Yard, other than main track
<b>Hazardous materials</b>	None
<b>Fatalities</b>	1
<b>Injuries</b>	0
<b>Damages</b>	\$89,000

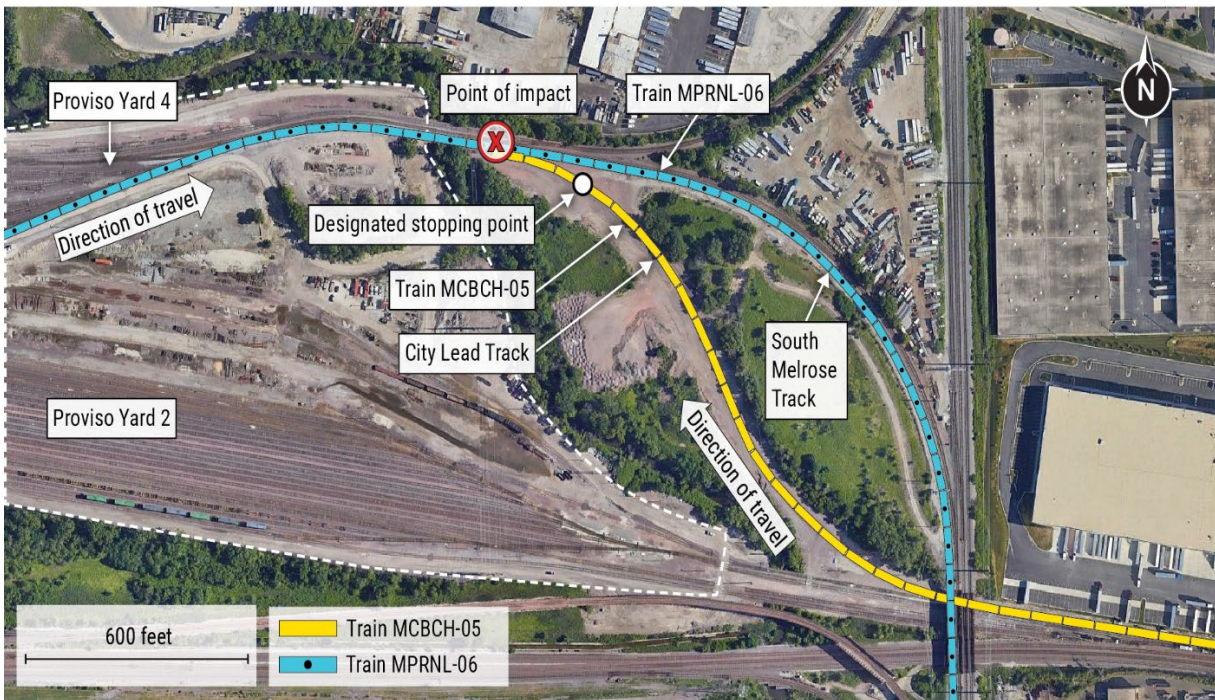
On July 6, 2024, about 1:36 a.m. local time, a Union Pacific Railroad (UP) conductor was killed in a raking collision while protecting a shoving movement at UP’s Proviso Yard in Melrose Park, Illinois.<sup>1</sup> At the time of the accident, eastbound train MPRNL-06 was traveling along the South Melrose Track out of Proviso Yard 4. At the same time, train MCBCH-05 was shoving west on the City Lead Track, which merges with South Melrose Track. The conductor of train MCBCH-05 was positioned on the leading end of a tank car when it struck the right side of train MPRNL-06.<sup>2</sup>

**Figure 1.** An aerial view of the accident site.

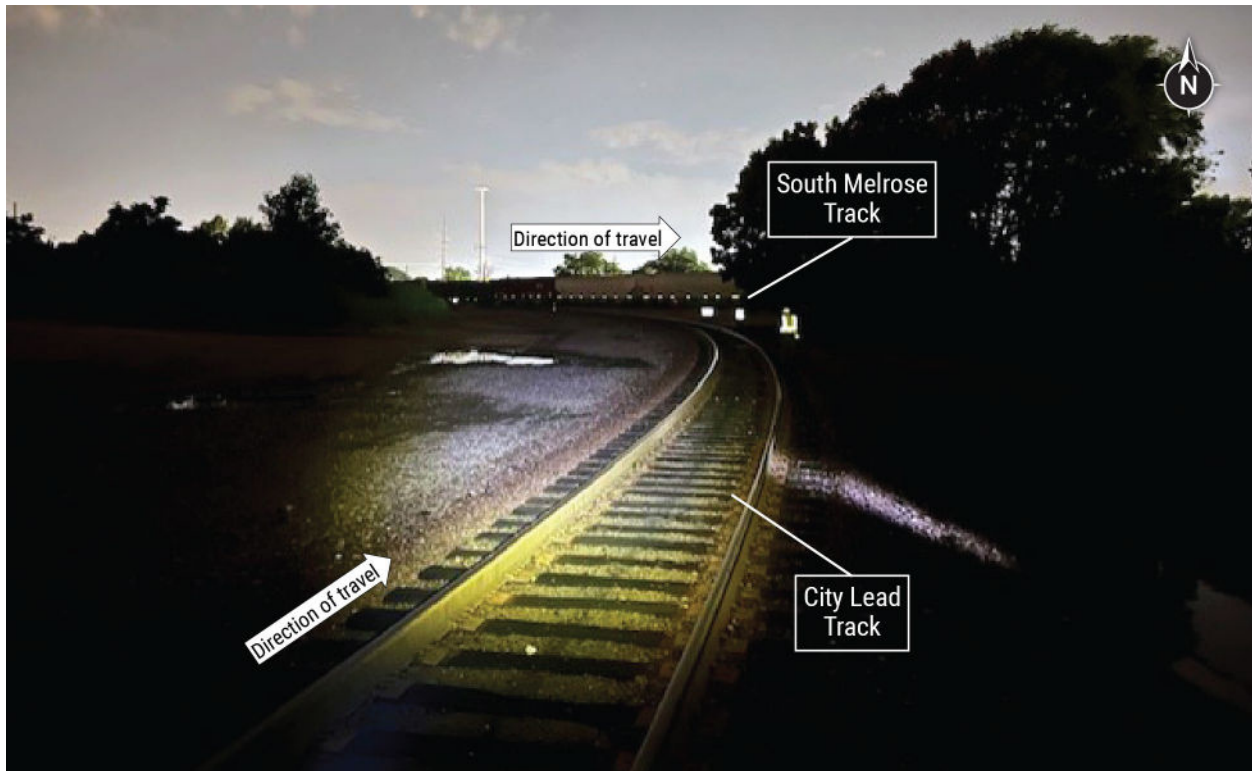
Postaccident sight distance observations demonstrated that a train pulling east on the South Melrose Track at the time of the accident would have been visible to a train making a shoving movement at 3.7 miles per hour up City Lead Track prior to traversing the designated stopping point. (See figure 2.)

**Figure 2.** A postaccident sight distance observation image of the City Lead Track demonstrating visual range as it would have been during the accident.

The raking collision, and the subsequent death of the striking train conductor, resulted from the train shoving past its designated stopping point. The conductor did not alert the engineer in time to safely stop the train from traversing the track and colliding with the departing train.

did not know precisely where City Lead Track merged with South Melrose Track and failed to alert the engineer to halt the train at the designated stopping point, which ultimately caused the collision. The conductor had minimal experience leading shoving movements after UP certified him, and he was not adequately familiar with the territory on which he was working when the accident occurred. The conductor's inexperience and lack of familiarity with Proviso Yard and the surrounding area left him unprepared to carry out his job requirements safely on his own.
