Railroad Investigation Report RIR-25-11

Middlesex Corporation Employee Fatality on Housatonic Railroad Company-Operated Line

Great Barrington, Massachusetts
August 4, 2023

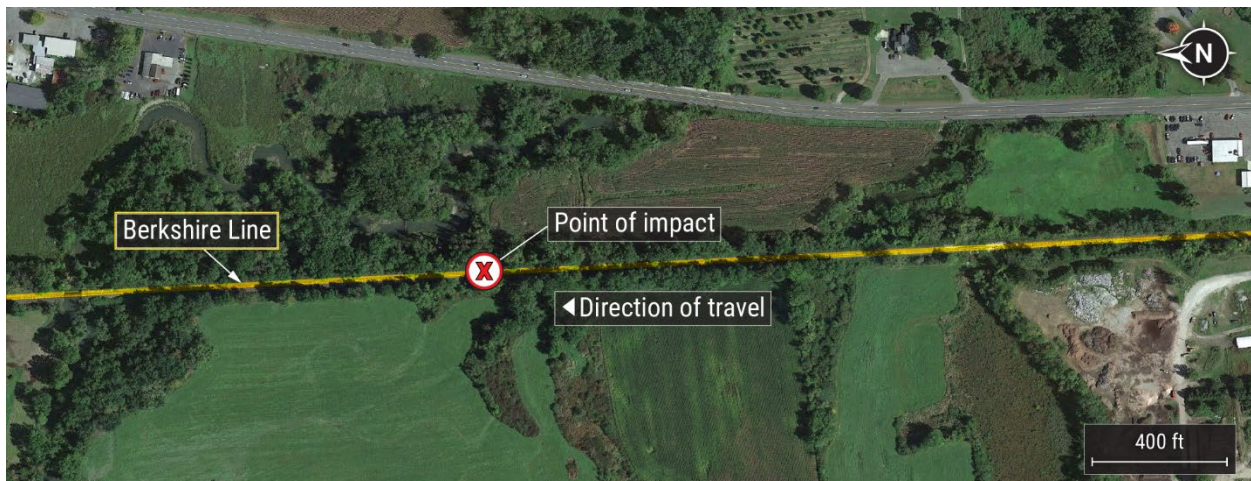
On August 4, 2023, about 10:05 a.m., a tie drilling roadway maintenance machine (RMM) being operated in reverse by a Middlesex Corporation employee struck and killed another Middlesex employee performing maintenance-of-way work on the Berkshire Line in Great Barrington, Massachusetts.¹ The RMM involved in the accident is commonly referred to as a driller. At the time of the accident, the driller operator (accompanied by another Middlesex employee) was conducting a reverse movement along the Berkshire Line to resume work after having relocated the driller to a separate location for repair about an hour before the accident. While conducting the reverse movement, the driller operator did not see that two fellow Middlesex employees were working in the driller's path of travel; subsequently, the driller struck and killed one of the employees. (See figure 1.) There were no other injuries. The temperature at the time and location of the accident was 66°F with no precipitation. Visibility was clear and unobstructed at the accident location.

Figure 1. Overhead view of the accident site. (Background image courtesy of Google Earth.)

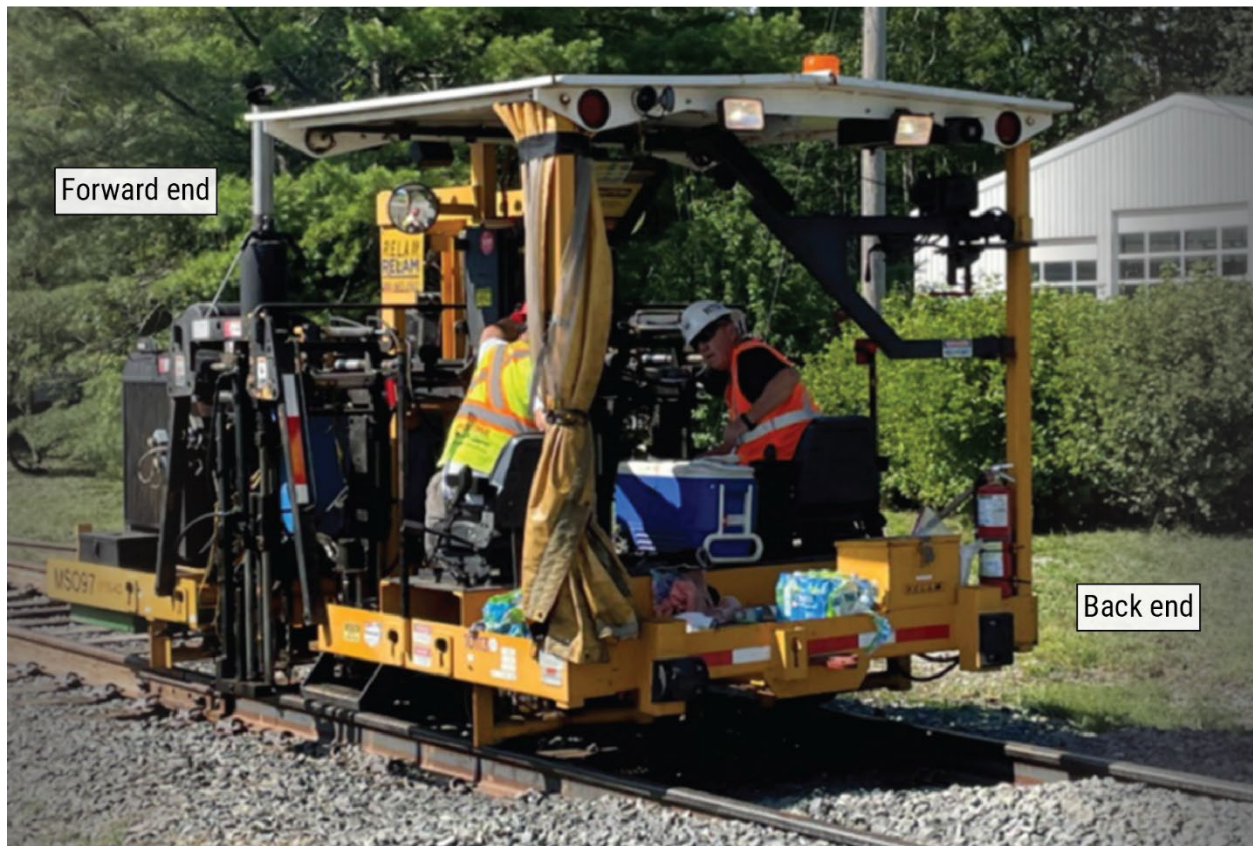
When the RWIC left to join work group 1, the four employees of work group 2 were still at Lanes moving various RMMs to access the driller and lagger they needed for their assignment and to prepare other RMMs for future work. About 8:20 a.m., work group 2 completed their preparations and arranged the two RMMs on the main track for the day's work. The lagger was positioned on the track to the north of the driller, and both RMMs were facing south. A rail cart was connected to the driller using a tow bar at the rear (north) end. Work group 2 then departed north, in reverse, to travel to their work location. Figure 3 shows the driller that was involved in the accident. At the time of the accident, the operator was in the driver (left) seat and moving the driller in reverse.

Figure 3. Tie drilling machine MS097 reenactment photograph.

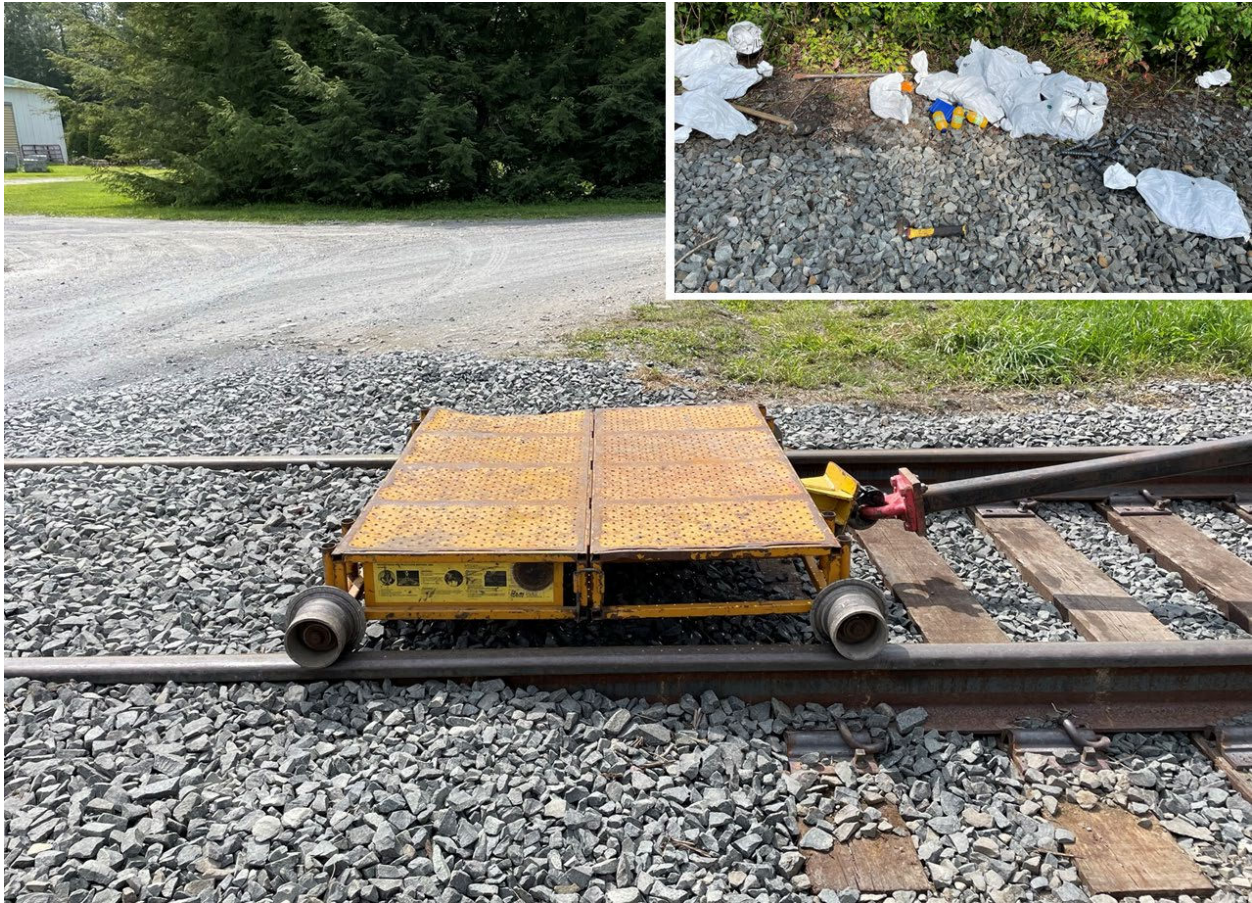
During his postaccident interview, the driller operator told the NTSB that, as he approached the accident location in reverse, he scanned his mirrors and looked over his shoulder to watch his route along the rail. He said that he saw the lagger in the same location it had been in when he left the location for repairs, and he saw employee 2 from about 300 feet away. The driller operator also said that he saw employee 2 clear the tracks as he passed him, but he did not see employee 1. He said he heard employee 2 yelling as he continued moving the driller past employee 2's position. The driller operator said he then turned his head to look back, saw employee 1, and applied the foot brake as the driller struck employee 1. He said the driller also struck the rail cart before coming to a stop. Figure 4 shows the rail cart that was struck by the driller and, in the inset, tools and nylon bags of material that were on the cart when it was struck.

Figure 4. The rail cart struck by the driller.

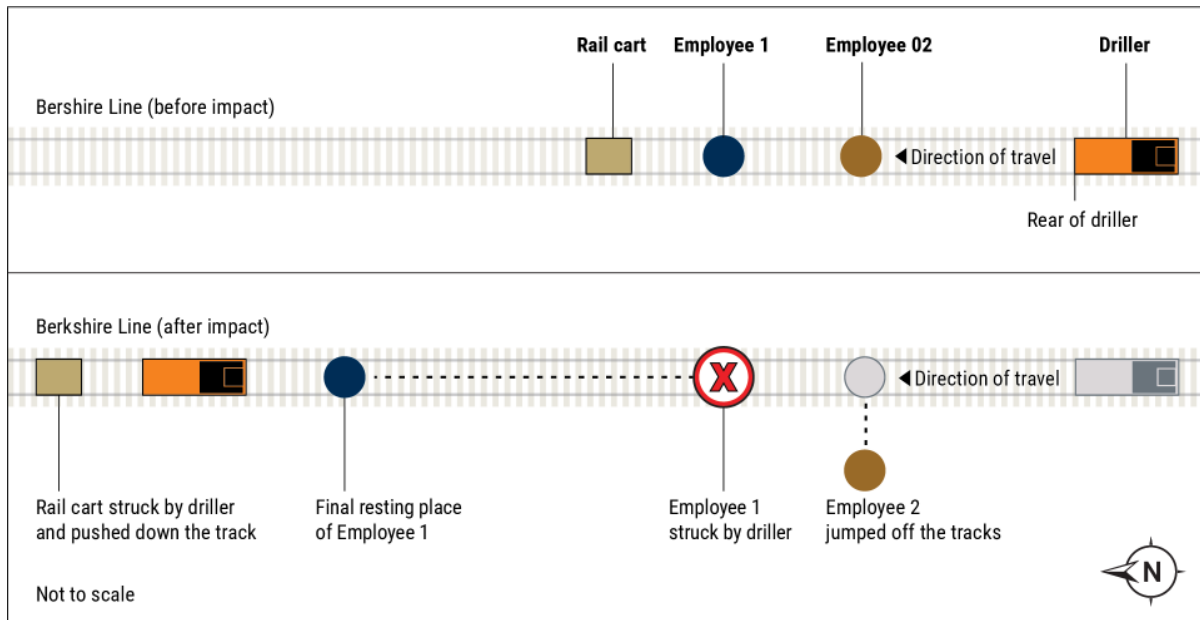
Employee 1 fell to the ground between the rails when he was struck by the driller. The driller passed over the employee and struck the rail cart. When the driller came to a stop, employee 1 was in front (south) of it. (See figure 5.) The work group immediately called 911, contacted supervisors, and assisted emergency responders with accessing the accident location. First responders transported employee 1 by helicopter to Baystate Medical Center, where he was later pronounced dead.

Figure 5. Diagram of the accident sequence.

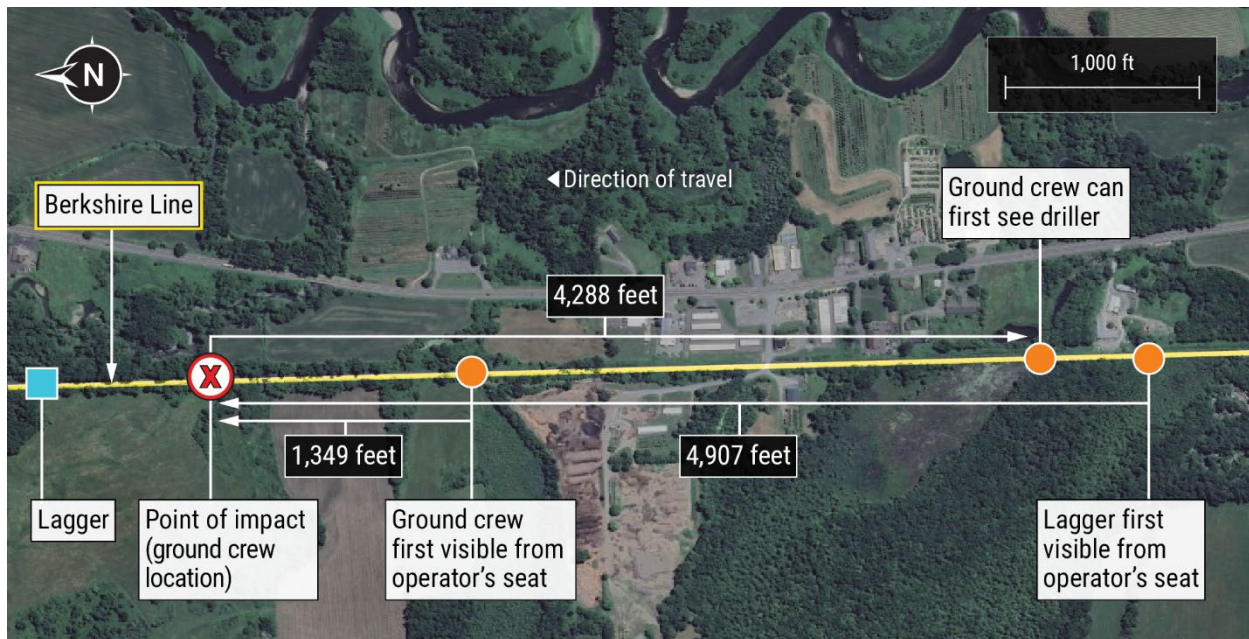
- The investigator could first see the stationary lagger from either of the two seats in the driller when the driller was about 4,900 feet from the point of impact.
- Investigators on the ground at the point of impact could first see the driller when it was about 4,300 feet away.
- The investigator in the driller could first see the investigators on the ground from either of the two driller seats when the driller was about 1,300 feet away.

Figure 9. Sight distance observation results. (Background image courtesy of Google Maps.)
