New Jersey Transit Light Rail Vehicle Collision

Location	Florence, New Jersey
Date	October 14, 2024
Accident type	Employee fatality
Train	Train 207 2 articulated railcars 1 operator 41 passengers
Track	Federal Railroad Administration regulated track; Class 4 main, signalized
Hazardous materials	N/A
Fatalities	1
Injuries	23 minor injuries
Property Damage	\$194,000

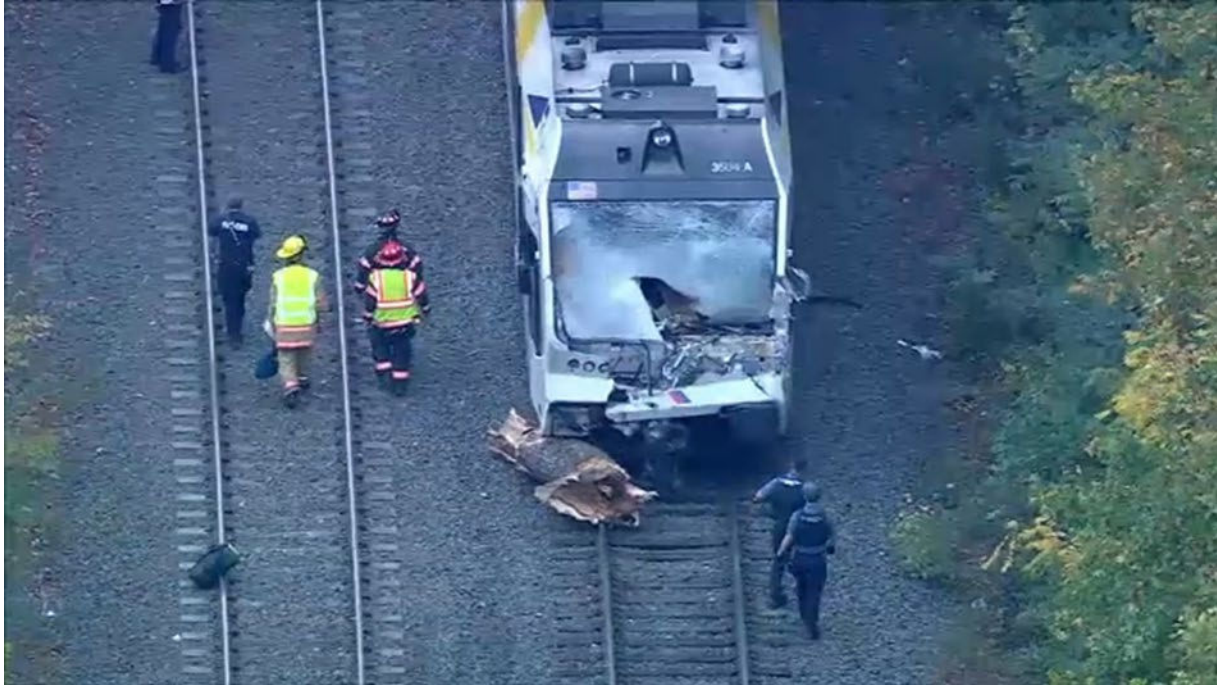
On October 14, 2024, about 5:58 a.m., an Alstom employee operating southbound New Jersey Transit (NJ Transit) train 207 was fatally injured when the train struck a tree that had fallen across the tracks of the River Line at milepost (MP) 24.53 near Florence, New Jersey.¹ (See figure 1.) Train 207 was a light rail vehicle consisting of two railcars with 41 passengers on board.² During the collision, a tree branch penetrated the lead railcar’s forward windshield and struck the operator. Twenty-three passengers were

Figure 1. Aerial view of damaged train and portion of struck tree in their final positions. (Source: 6abc Action News.)

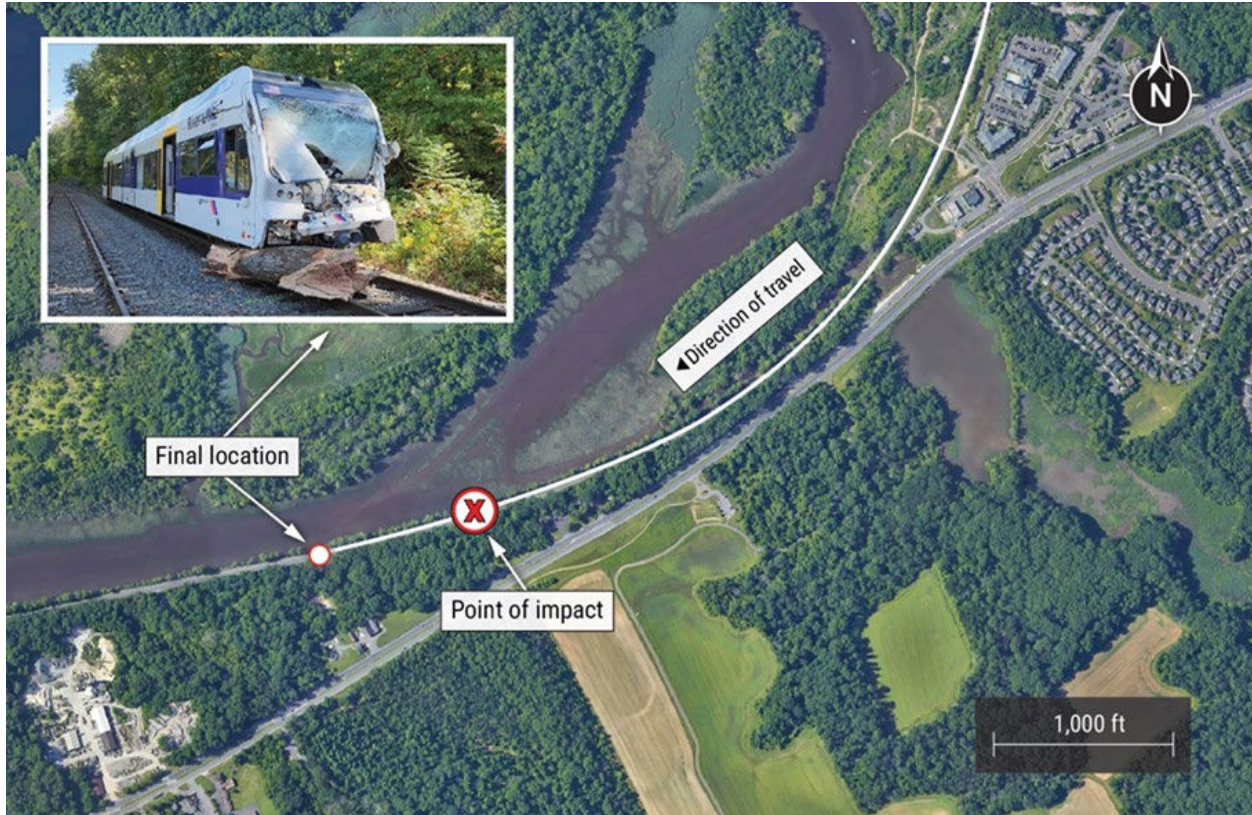
On the day of the accident, the operator reported for duty at 4:48 a.m. at an NJ Transit maintenance facility in Trenton, New Jersey. She started her scheduled trip from Hamilton Avenue Station at 5:47 a.m., operating train 207. This was the first train to operate on the River Line that day. About 5:55 a.m., the train departed Bordertown Station, the last station north of the accident area. According to event recorder data, the operator initiated an emergency braking application at 5:58:56 a.m. while rounding a right-hand curve north of the point of impact. The train was traveling 65 mph when the braking application began, and the train decelerated for several seconds before striking the tree.³ The train came to a stop about 880 feet past the estimated point of impact. (See figure 2.)

Figure 2. Satellite image of accident location. (Source: Google Earth.)

While on-scene, the National Transportation Safety Board (NTSB) identified abrasive transfer marks on the rails consistent with emergency braking starting near MP 24.61, or about 430 feet north of the point of impact. Because the head end of the train was about 90 feet from its rearmost axle, this corresponds to an emergency braking application beginning when the head end of the train was near MP 24.59, or about 340 feet from the point of impact. The marks ended at the point of impact.

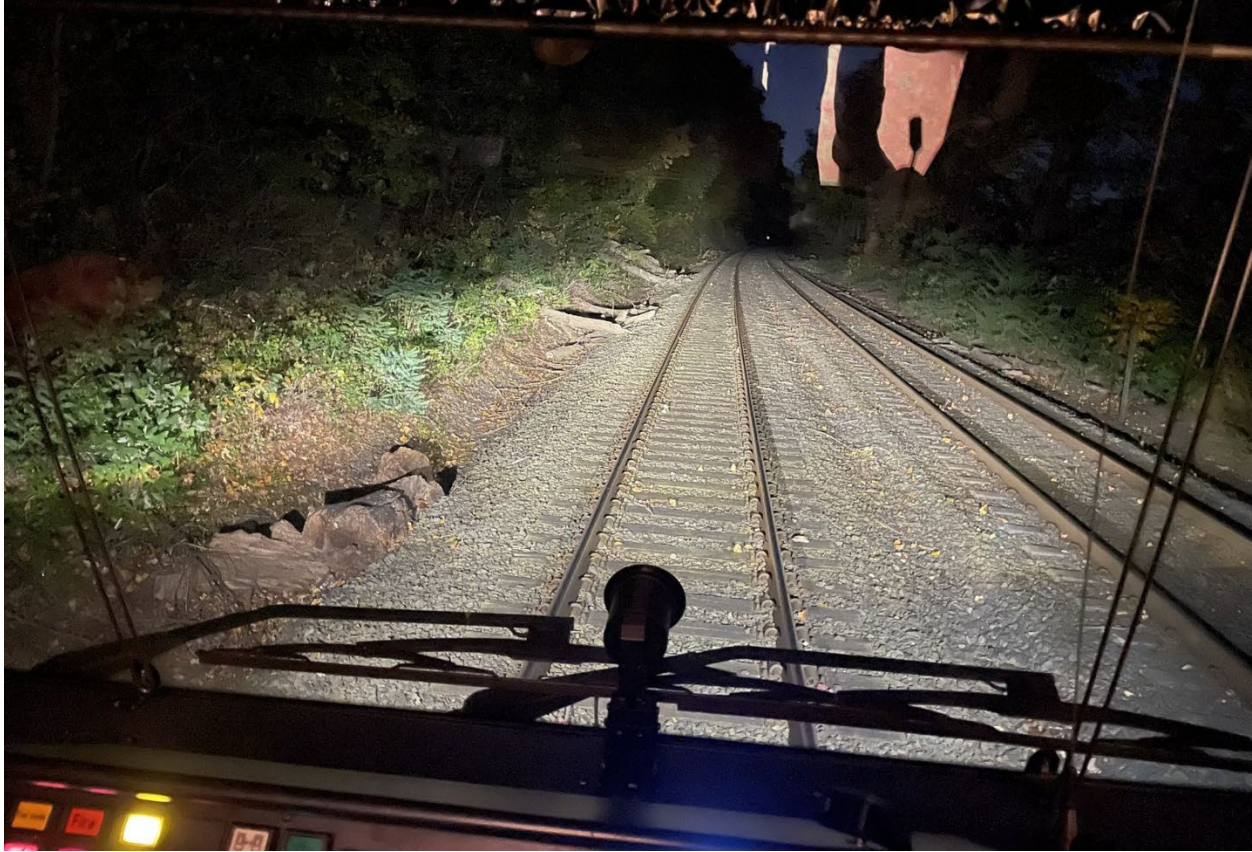
The NTSB conducted a partial reenactment of the accident at low speed under predawn lighting conditions. (See figure 3.) During this reenactment, the fallen tree became visible to an approaching train operator about 350 feet north of the point of impact. According to waivers NJ Transit filed with the Federal Railroad Administration (FRA) when obtaining approval to operate, on FRA-regulated track, the type of light rail vehicle involved in this collision, the headlights were designed to illuminate a person

standing 500 feet away.⁴ Daylight observations of the scene found that the point of impact was visible from about 1,400 feet away.

Figure 3. View from test train cab during reenactment.
