American Freedom Train No. 1

Cosmetic Restoration Process

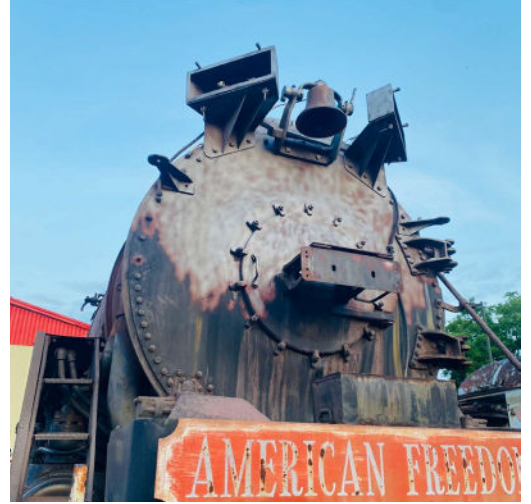
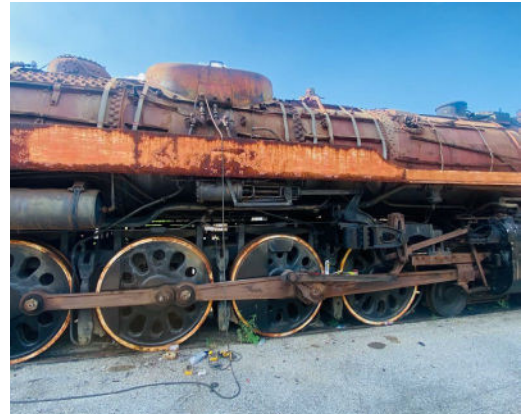
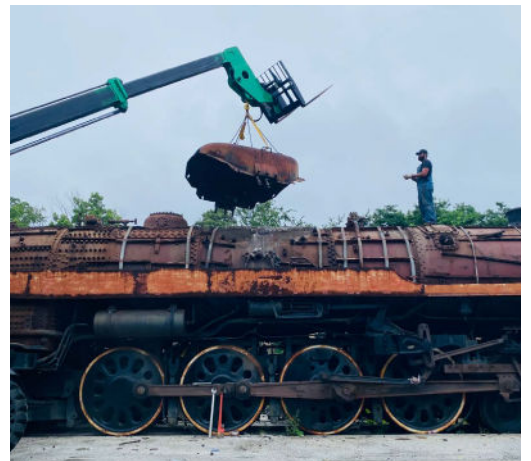
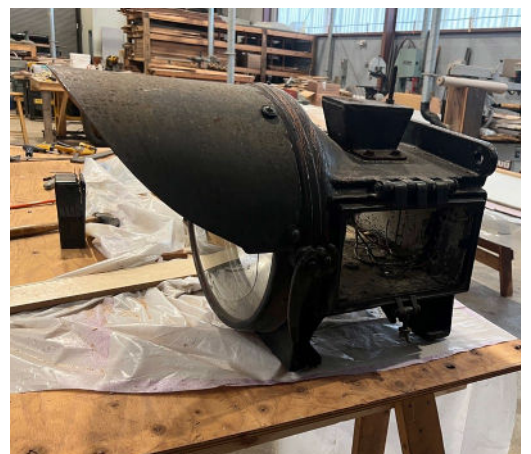
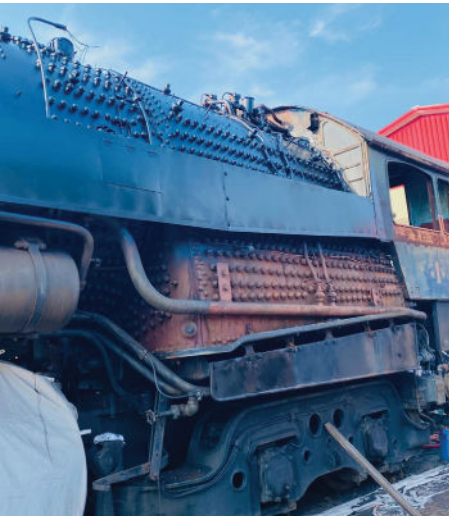
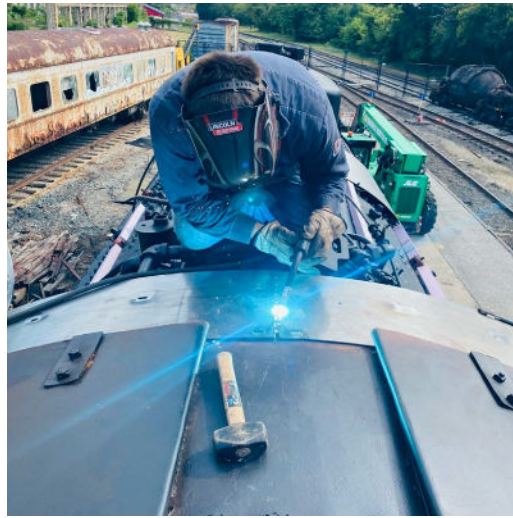
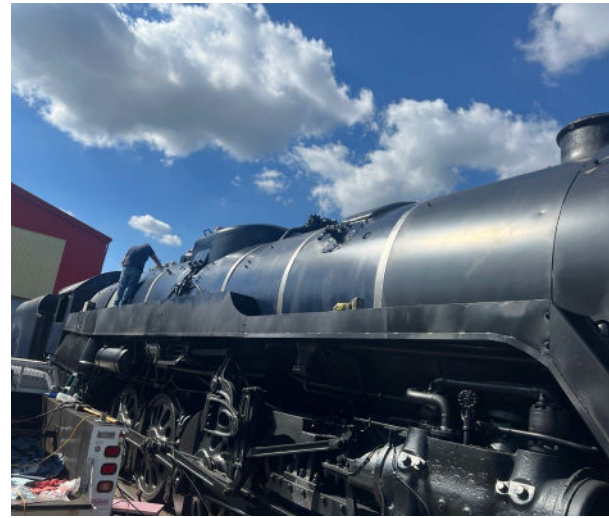
Before restoration, the locomotive showed widespread paint loss and discoloration, extensive corrosion of the exterior metal jacketing, failing internal spacers, and deterioration of decorative and mechanical exterior elements. Some original components were missing or damaged, and earlier paint applied as a temporary fix had fully failed.

All exposed metal surfaces were cleaned using media blasting to remove corrosion, failing paint, and contaminants. Areas of rust-through or structural failure were repaired or replaced. New steel jacketing was fabricated where original panels could not be saved, using original pieces as patterns to ensure accuracy.

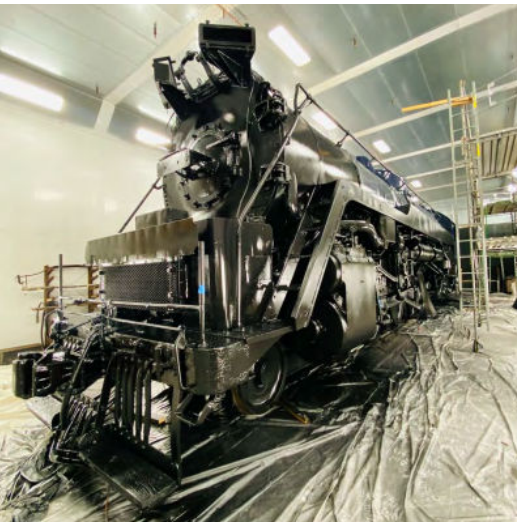
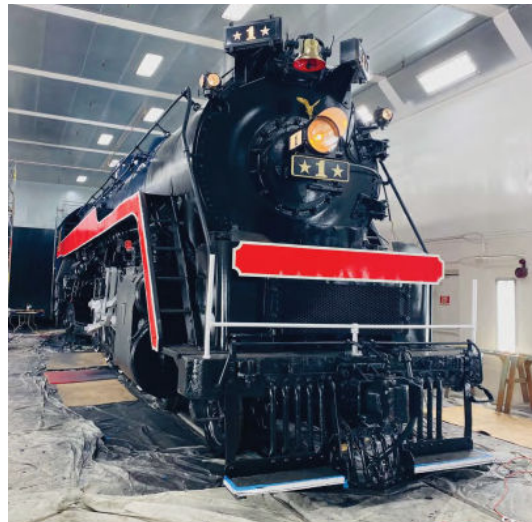
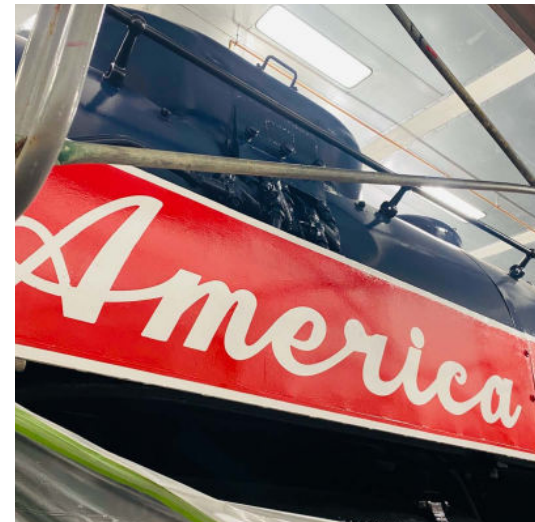
The original jacking had deteriorated significantly, with rust-through and failing internal spacers. New jacking was required to stabilize the exterior, prevent further corrosion, and create a sound surface for repainting. New internal spacer materials were installed to properly separate the boiler from the jacking.
