BNSF Railway Maintenance-of-Way Employee Fatality

Location	New Rockford, North Dakota
Date	November 4, 2024
Accident type	Maintenance-of-way employee fatality
Train	BNSF Railway freight train X-PTNNGT2-31A
Vehicle	BNSF Railway welding truck
Track	Single main track intersecting with farm road at highway-railroad grade crossing
Hazardous materials	None
Fatalities	1
Injuries	1
Damage	\$250,000

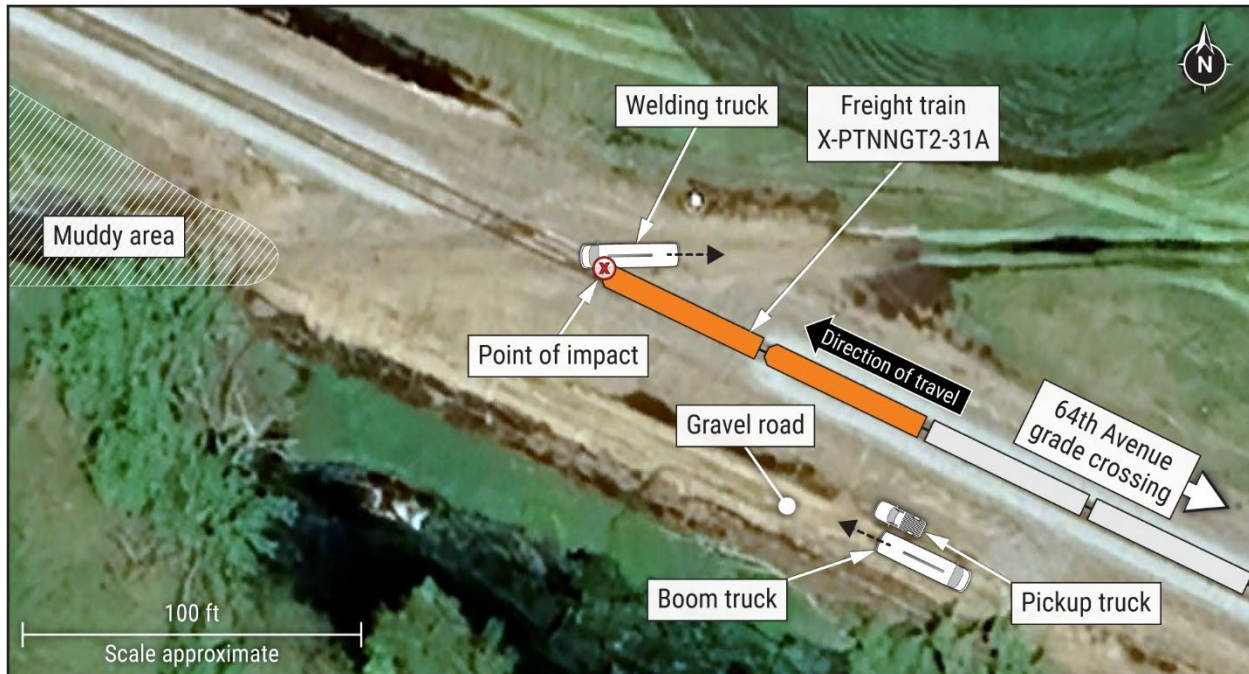
Figure 1. Aerial view of the accident site. (Source: BNSF Railway.)

At milepost 128.1, an unpaved farm road which ran east and west intersected the track at a skew angle of about 30°, making the grade crossing (accident grade crossing) a skewed intersection.⁶ The accident grade crossing was paved to facilitate the movement of vehicles and was at a higher elevation than the unpaved farm road. The accident grade crossing was passive but equipped with stop signs on either side of the track for eastbound and westbound vehicles traveling on the farm road.⁷ A gravel road on the south side of the track ran parallel to the track. This road was used by MOW employees to access the track for repair work.

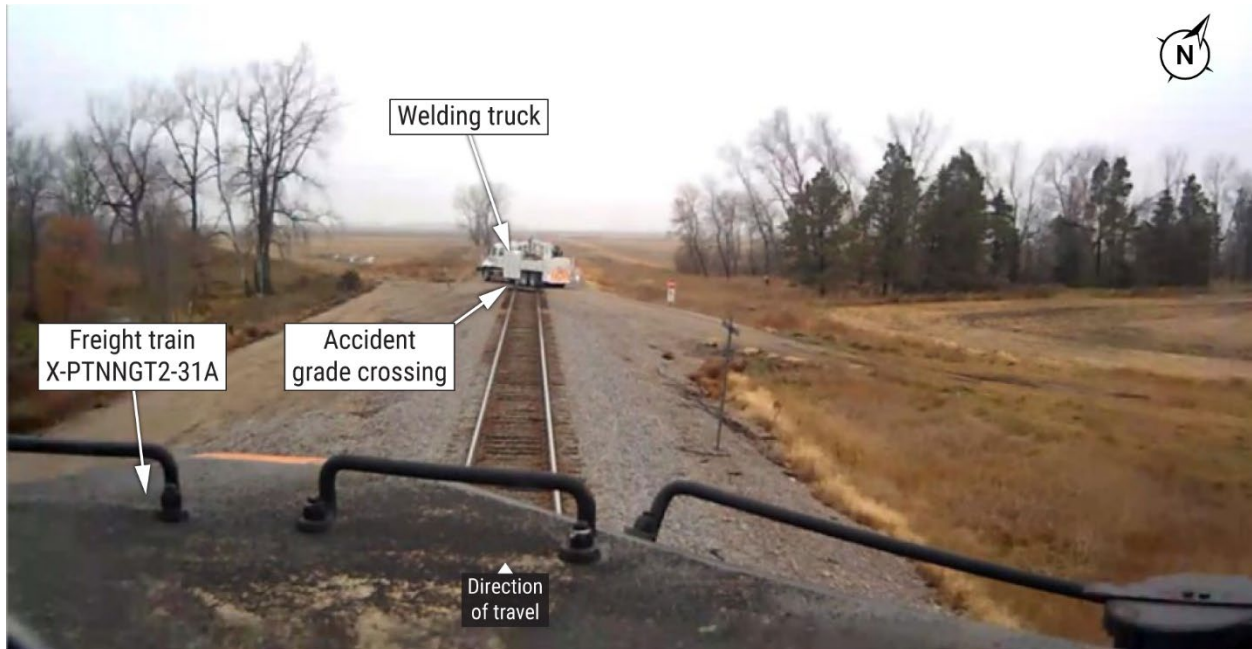
NTSB's review of the forward-facing cameras in the train's lead locomotive revealed that at 10:59:47a.m., the train horn sounded multiple times as the train approached the 64th Avenue grade crossing. NTSB's review of the inward-facing camera in the train's lead locomotive confirmed that the train crew was alert in the moments leading up to the accident. NTSB's interviews with the train crew revealed that the engineer and the conductor saw the welding truck at 10:59:47 a.m. when the train was approaching the 64th Avenue grade crossing. The engineer sounded the locomotive horn continuously as the train approached the accident grade crossing. Event recorder data showed that the engineer applied the emergency brakes at 11:00:16 a.m. and struck the welding truck at 11:00:19 a.m. before it could clear the accident grade

Table 1 is a timeline of the accident and Figure 2 is an image from the forward-facing camera of the train’s lead locomotive as it approached the accident grade crossing.

Figure 2. Image from the forward-facing camera on the train as it approached the accident grade crossing.
