## Illustrated Digest

# Norfolk Southern Railway Derailment and Subsequent Hazardous Materials Release

**East Palestine, Ohio • February 3, 2023**

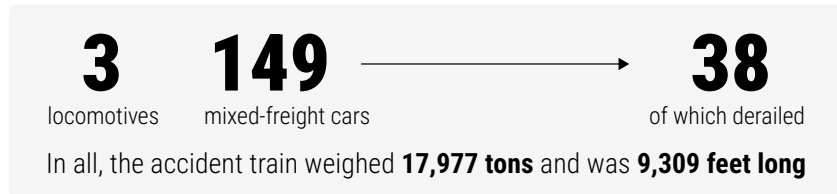
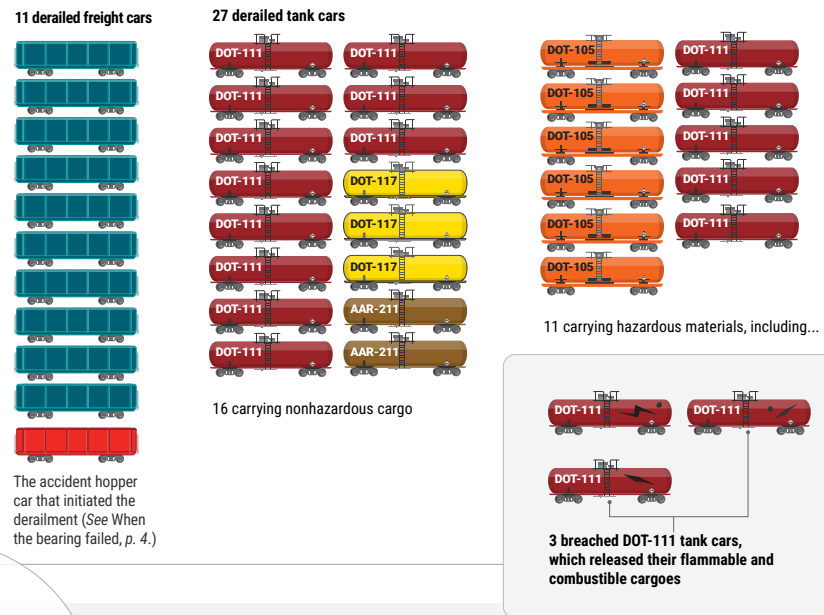
### DOT-111 tank cars in a derailment: flip a coin

In a derailment, DOT-111 tank cars fail about as often as a coin comes up heads when you flip it.

The NTSB’s 1991 safety study, *Transport of Hazardous Materials by Rail* found that 54% of DOT-111 tank cars involved in accidents in 1988–1989 were breached and released some or all of their contents.

More than 30 years later, we saw a similar breach rate at East Palestine: 8 of 16 derailed DOT-111s released at least some of their contents, with a breach rate of 44% from confirmed mechanical damage.

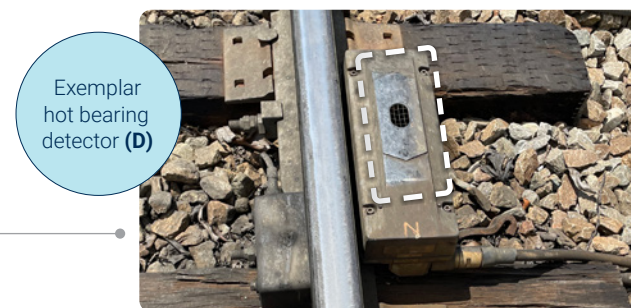
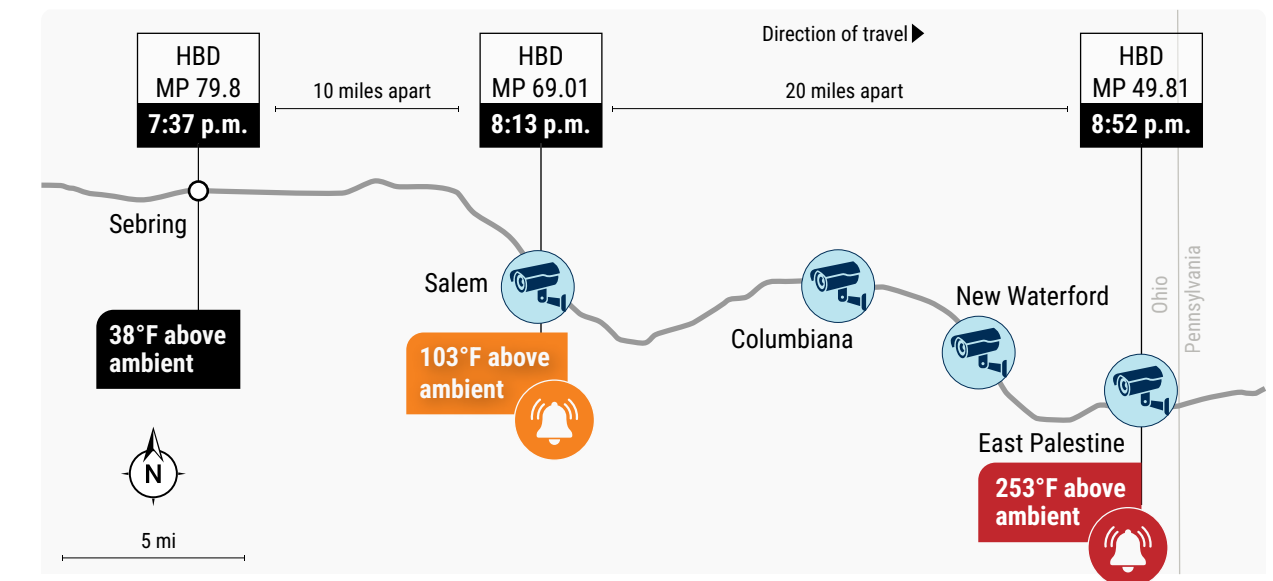
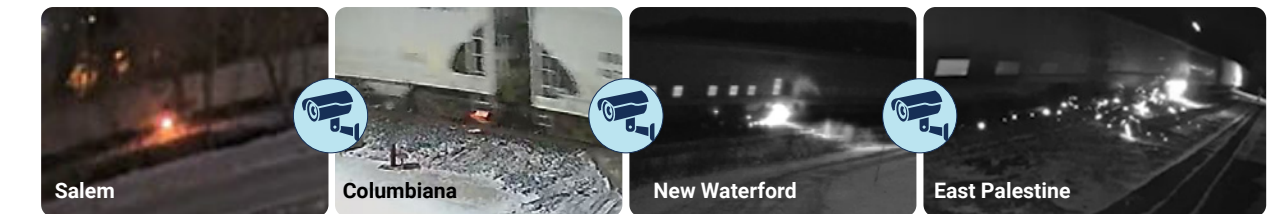
At 8:13 p.m., at the Salem HBD, the reading for the L1 bearing was 103°F above ambient. This reading was high enough to trigger a noncritical alert to the Wayside Help Desk (see box), but not to the crew. A surveillance camera picture from Salem showed fire near the bearing (right). Surveillance cameras in Sebring also captured images of the train, and no anomalies were noted.

Under NS rules, if a train's crew hears a critical alarm, they must stop the train right away and inspect the wheelset that triggered the alarm. The engineer began to slow the train before 8:54 p.m.

But it was too late; the hopper car and 37 others derailed as the train's emergency braking system activated.

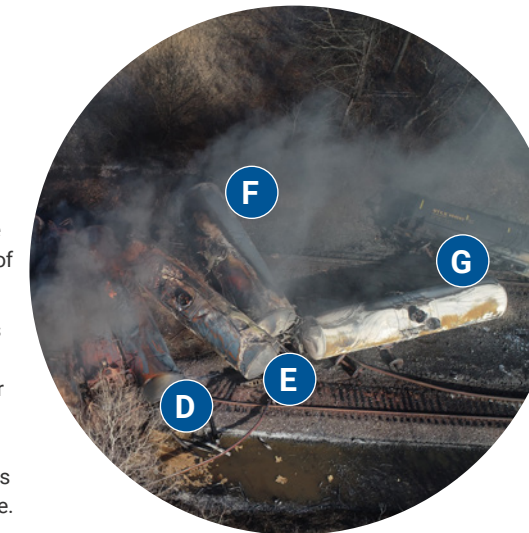
### Tank car temperatures, February 5

NS contractors tried to measure the VCM cars' internal pressures on February 4 and 5, but could not measure the pressure of cars exposed to pool fires. The pressure in the car that was not exposed to pool fires was stable. None of the tank cars was releasing VCM except through PRDs.

Also on February 4 and 5, NS contractors noted no signs of gas being released from the car that was resting against the burning hopper car (H), though a gas detector indicated the presence of volatile compounds near the top of the car. SPSI's president believed that VCM was leaking from this car, but that polymerization inside the car was preventing it from releasing at large enough quantities to catch fire.
