American Freedom Train No. 1

Cosmetic Restoration Process

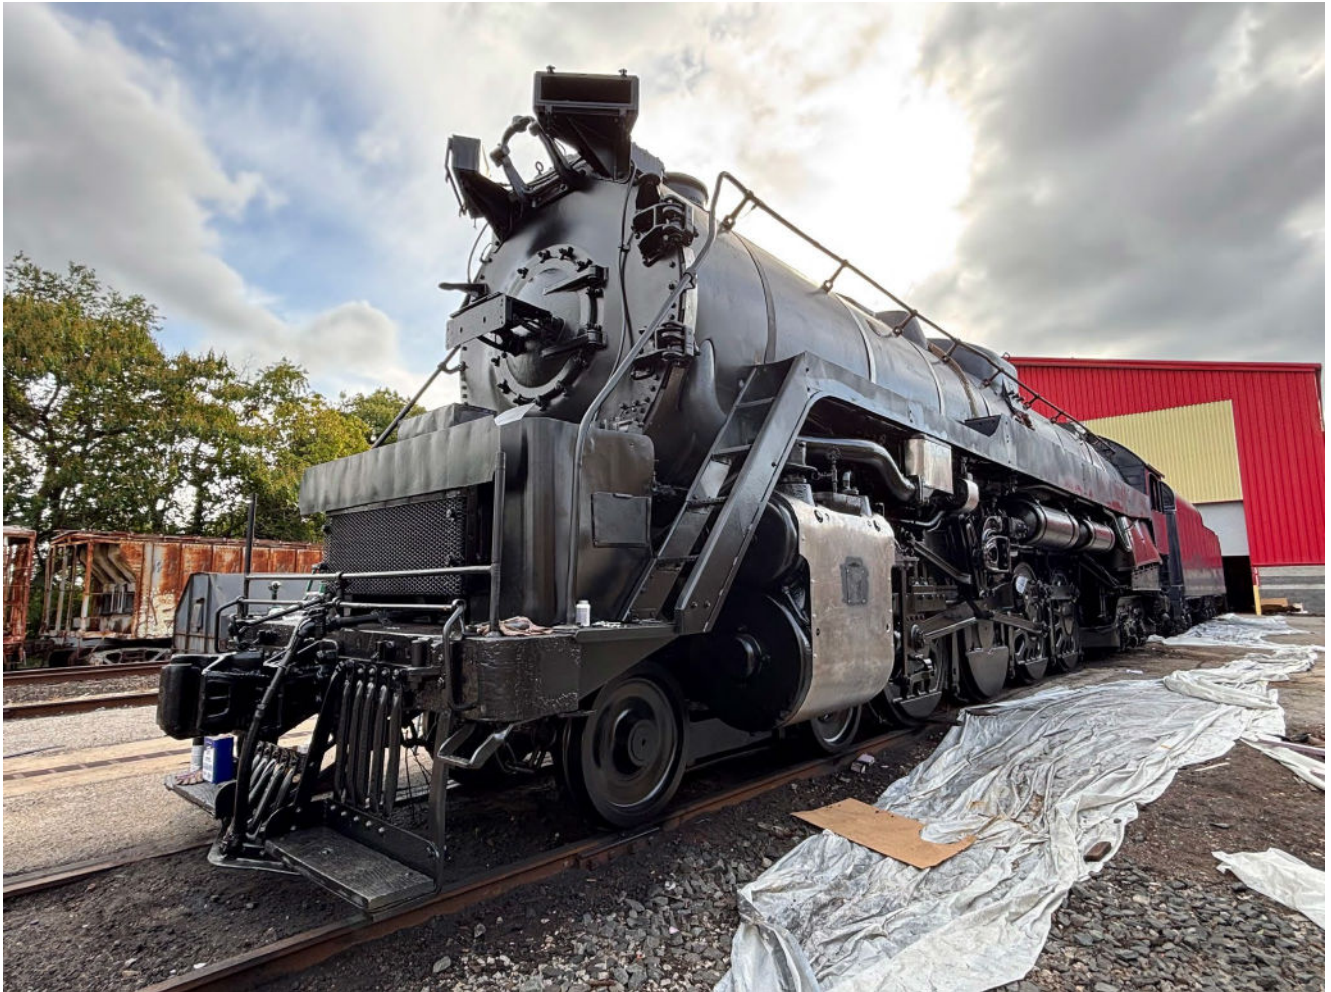
Before restoration, the locomotive showed widespread paint loss and discoloration, extensive corrosion of the exterior metal jacketing, failing internal spacers, and deterioration of decorative and mechanical exterior elements. Some original components were missing or damaged, and earlier paint applied as a temporary fix had fully failed.

The project was a comprehensive cosmetic restoration, focused on stabilizing, repairing, and accurately restoring the locomotive's exterior appearance and cab interior. The work was designed to preserve the locomotive for long-term public display.
