The Washington Metrorail Safety Commission

of the Washington Metropolitan Area Transit Authority
Audit of Emergency Management and Life Safety Programs

Final Report:
January 29, 2025

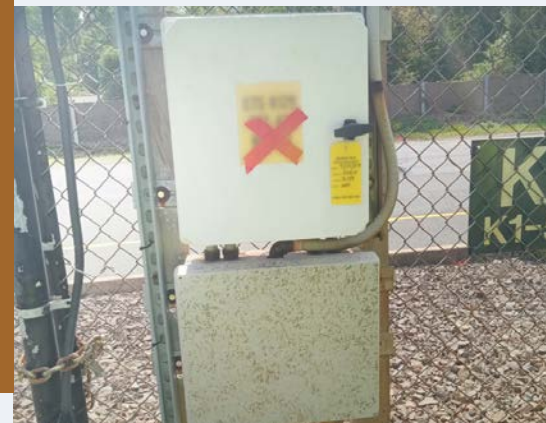
Metrorail's asset list shows 2000 Emergency Trip Stations (ETS) throughout the Metrorail system. There are ETS located every 800 feet along the roadway. ETS have two life safety critical features, which can be used independent of each other: A phone that provides a direct connection to the control

center and a red push button capable of de-energizing third rail power in a pre-defined segment of the roadway. Responsibilities for inspection, preventive maintenance, and corrective maintenance are assigned to multiple departments including Safety and Readiness, the Office of Power, Digital Modernization, and Facilities Maintenance. As of September 9, 2024, there were open work orders for 55 ETS boxes, which had varying functionality issues.

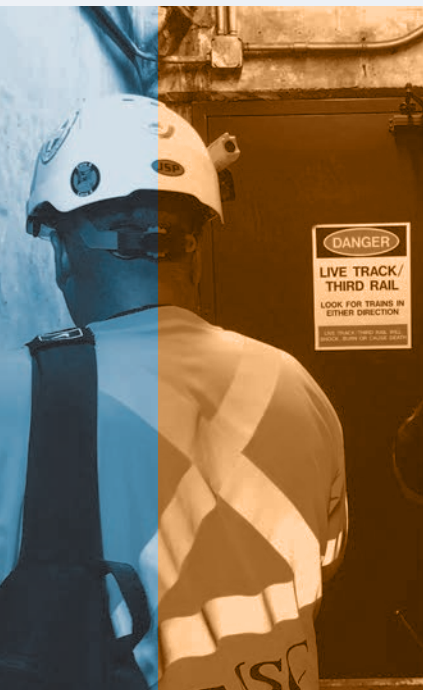
**Of the 12
Emergency Trip
Stations reviewed,
9 were in need of
repair.**

As of September 9, 2024, there were 55 open/incomplete work orders related to the ETS boxes with some open for over two months. On September 12, 2024, WMSC personnel conducted observations by conducting a track walk on Track 2 (West Falls Church to Dunn Loring) with personnel from Metrorail's Department of Digital Modernization to examine ETS boxes. Of the 12 Emergency Trip Stations reviewed, 9 were in need of repair.

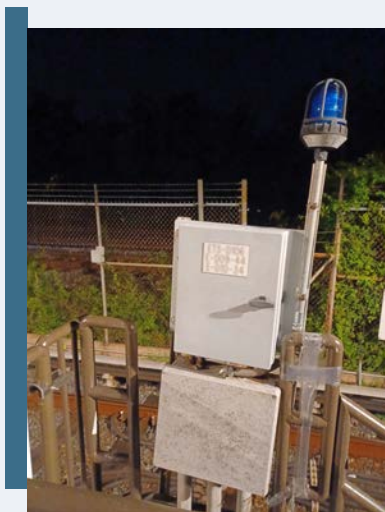
Metrorail has two different preventive maintenance inspections for ETS box enclosure inspection and trip verification testing: PWR 1241.1 is for all ETS boxes excluding the Silver Line and PWR 1241.2 applies only to the Silver Line’s ETS boxes. The Silver Line’s emergency trip stations differ from ETS on the rest of the Metrorail system in that they have a remote monitoring system with specific instructions stated in PWR 1241.2 that do not exist in PWR 1241.1. This ETS Remote Monitoring (ETSRM) system is provided in a separate box adjacent to the ETS box.
